Historic Building Assessment **Peterborough Town House** Peterborough, New Hampshire

5 November 2015

Peterborough Town House Historic Structure Report

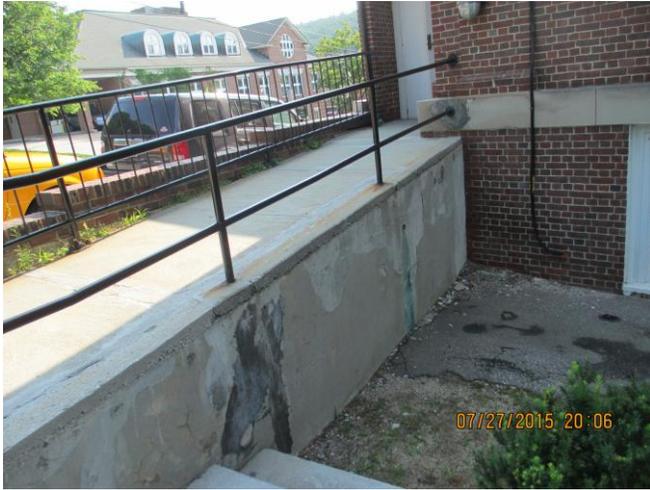
- The brick and concrete retaining wall at the ramp has bricks with face cracks both horizontal and vertical. There are no weepholes and no cap flashing.
- The exterior wood stile and rail door is in poor condition. It is weatherstripped improperly. The joints between wood and brick require caulking.
- The joints around the sprinkler drain and the Siamese connections need caulking.
- The copper roof, gutter and downspout all appear in good condition.
- The handrail connection at the wall is loose.

Damaged parking at the ramp retaining wall

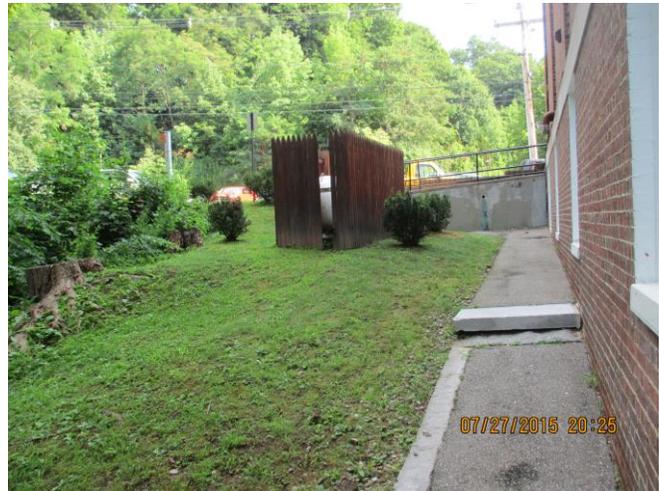
Missing slats at the fence around the propane tank

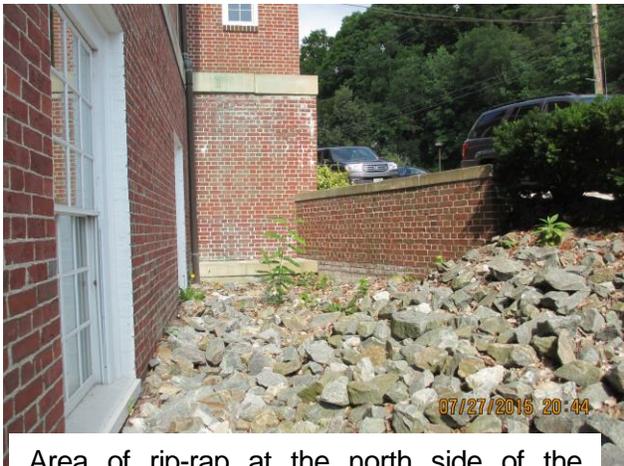
Area of rip-rap at the north side of the building. This is the approximate location of the leak observed at the time of the site visit

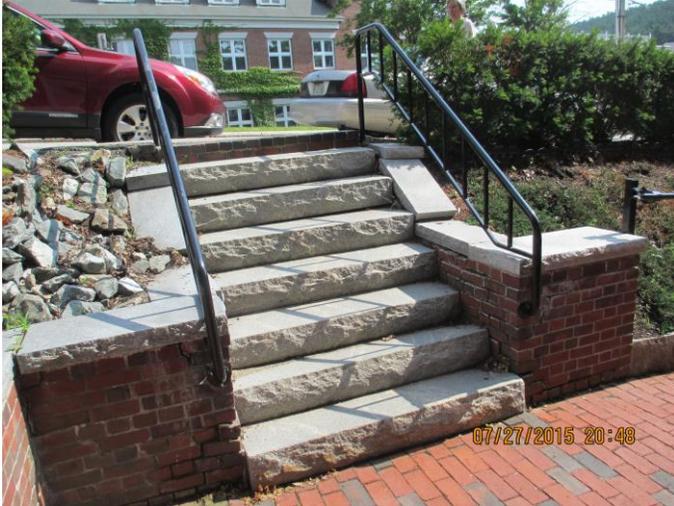
- Along the north side of the building there is a short brick site wall. The condition is generally good, but it is in need of some minor re-pointing. A second short site wall to the east of the addition is not flashed. The area east of that wall, adjacent to the building, is filled with six inch rip-rap. A set of granite steps leads down from the Main Street sidewalk to the north entry door. The top riser and tread are brick. The steps have settled and should be re-set. The steel handrails do not have extensions at the top or bottom. The brick retaining walls at either side of the steps are in poor condition and need rebuilding.

Retaining walls in need of repair at either side of north stair

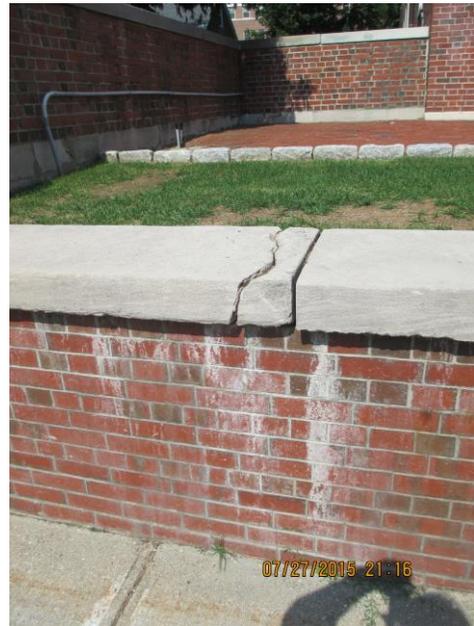
The limestone caps of the landscape walls have open joints that need caulking

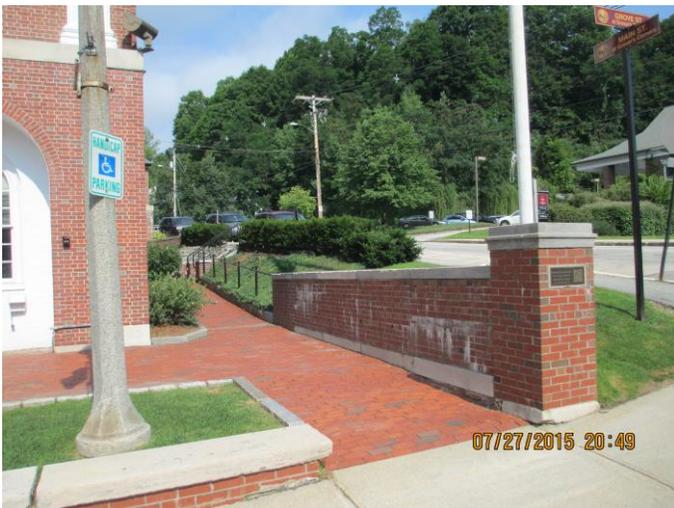
Spalling and efflorescence at the north landscape wall

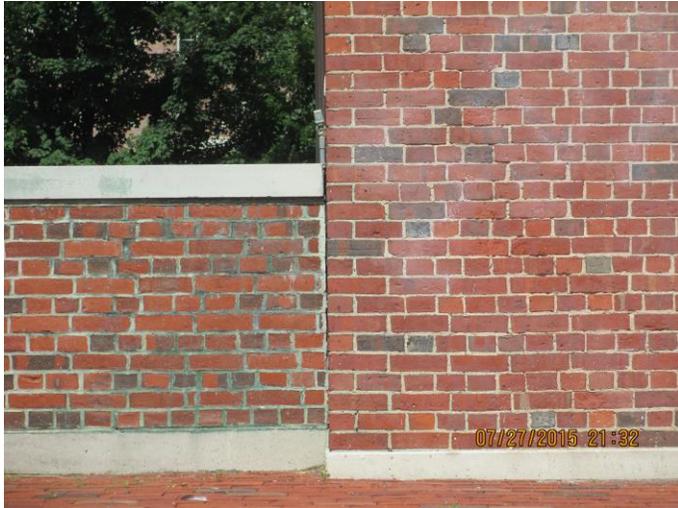
Joints between landscape and building walls need caulking

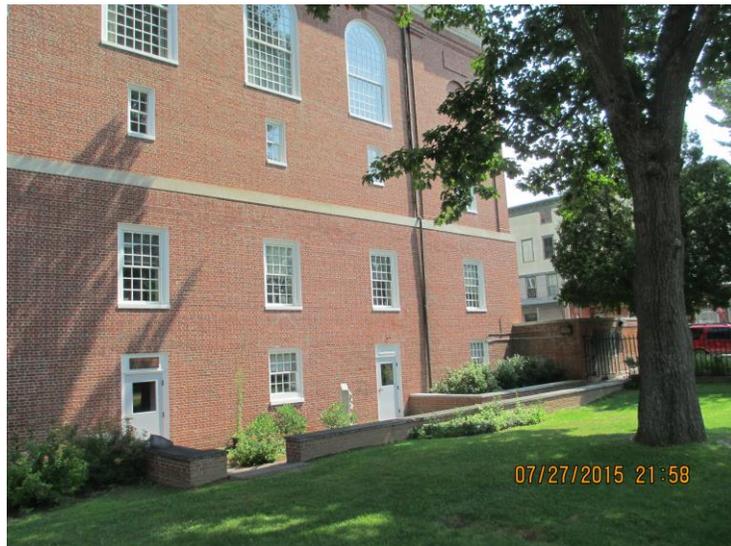
The oak tree at the south side of the building needs trimming

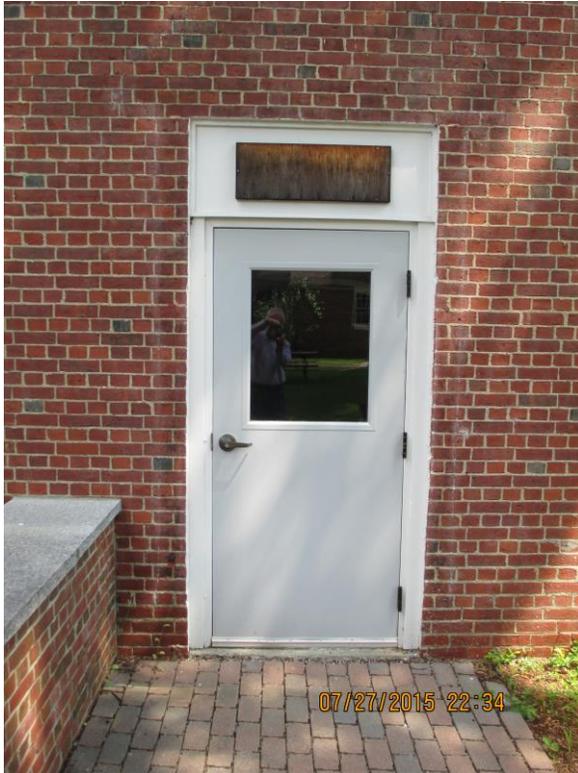
- The two eastern – most doors into the basement are flush metal doors in steel frames with wood trim and fixed wood transoms. The doors have insulated glass lites. The brick walk at the center door needs to be re-set to make the entrance accessible. The finish on the lever handle locksets is in poor condition. The locksets need to be repaired or replaced. The Mechanical Room door is a wood stile and rail door with insulated glass and true divided lites. The weatherstripping and hardware are in good condition.

Brick walkway at basement entry door needs to be reset to meet accessibility requirements

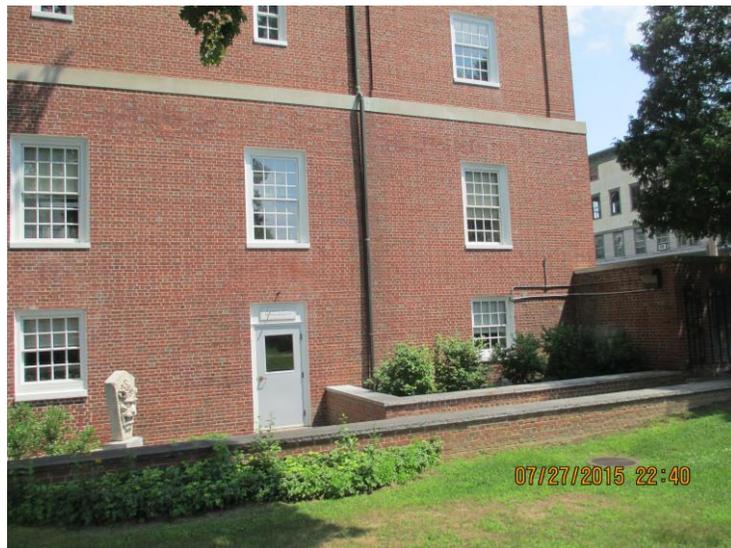
- The joint between the landscape wall and the building at the southeast corner needs repair.
- Electrical conduit that feeds two wall packs penetrates through the wall from the interior of the building and extends down a length of the exterior. This should be relocated to the interior, as much as possible.

Electrical conduit to be moved on the south wall

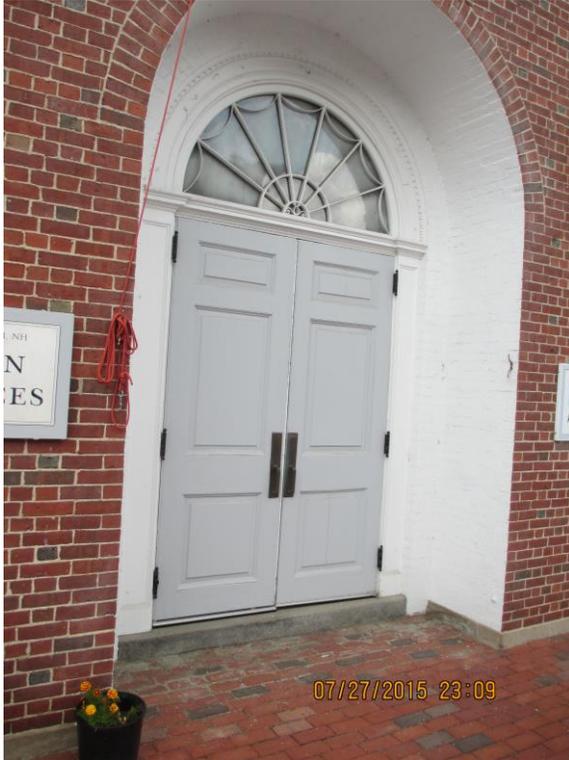
The fanlights over two of the entry doors are painted white on the interior

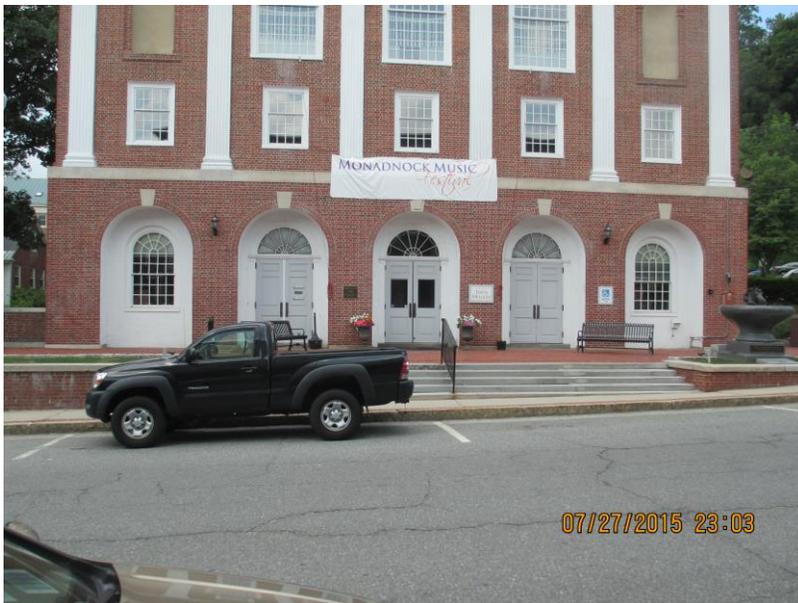
The exterior light fixtures are not in proportion with the scale of the building

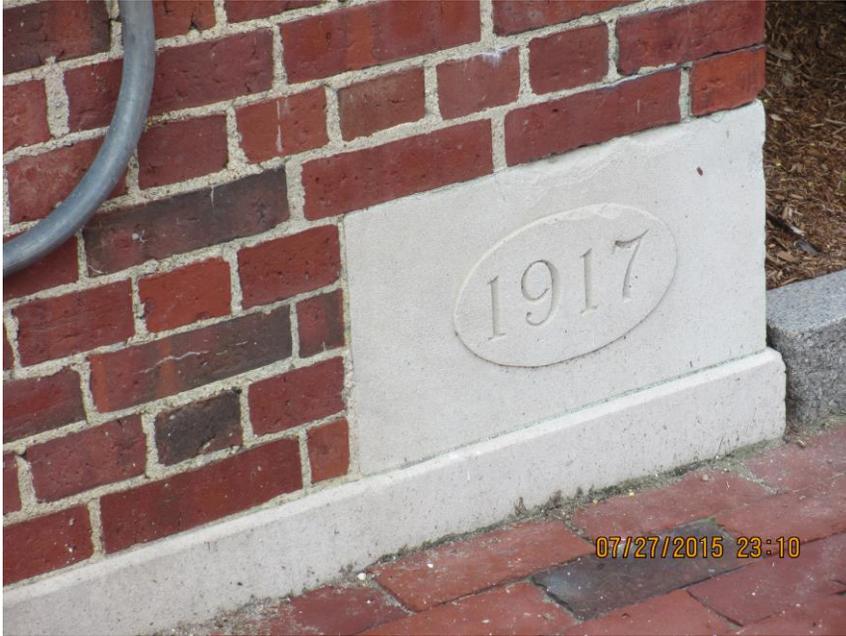
- The four inch high limestone base is in generally good condition, with just a few chips in it.
- The limestone cornerstone needs to have its joints re-pointed

The joints around the cornerstone need re-pointing

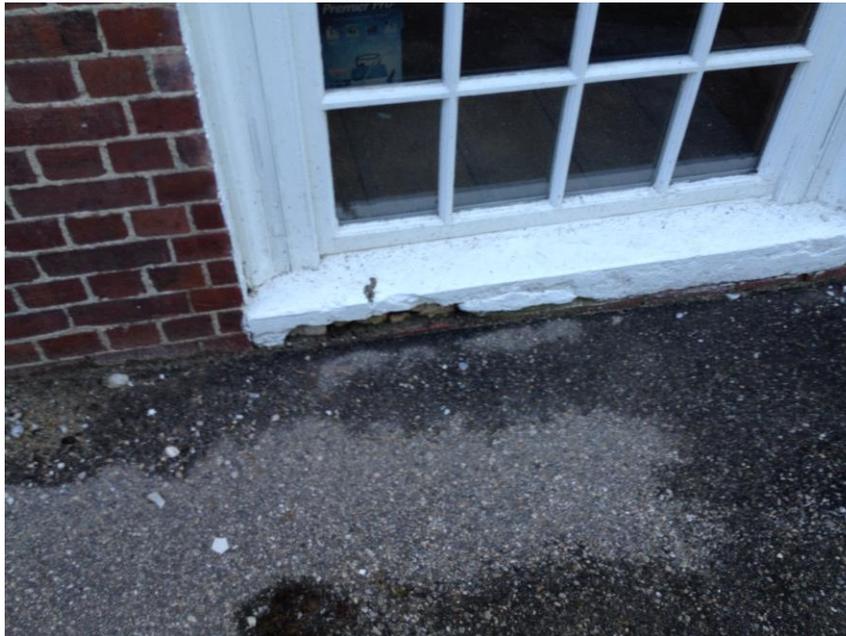
Damaged sill at basement window

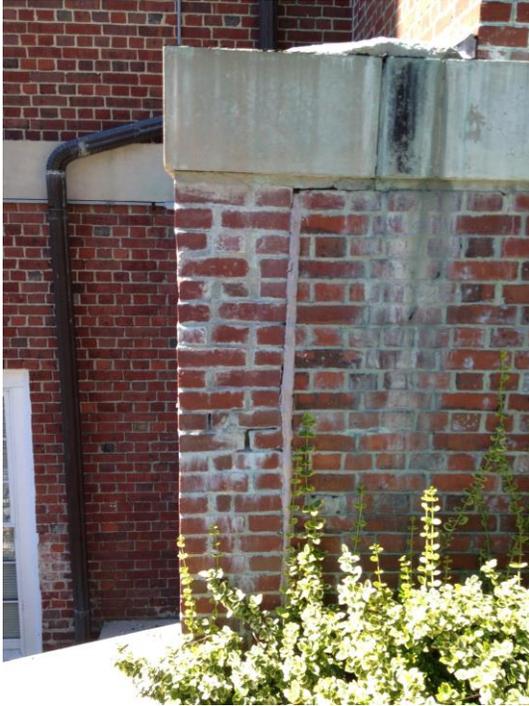
Brick damage at the north addition

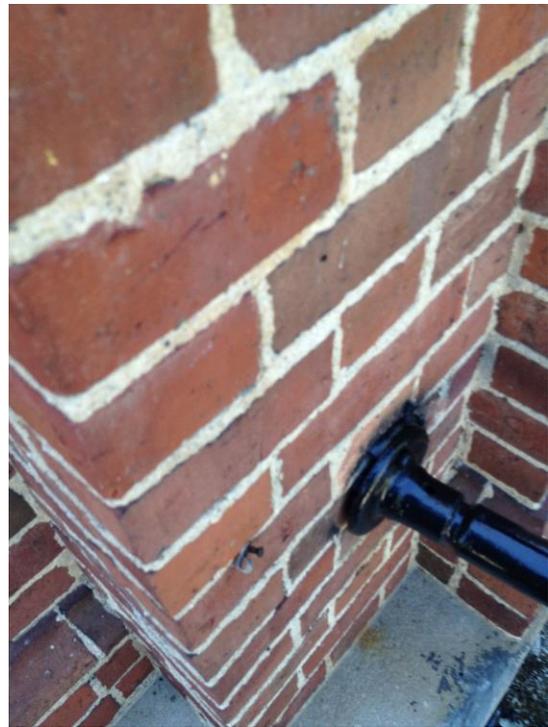
Loose connection at north addition handrail

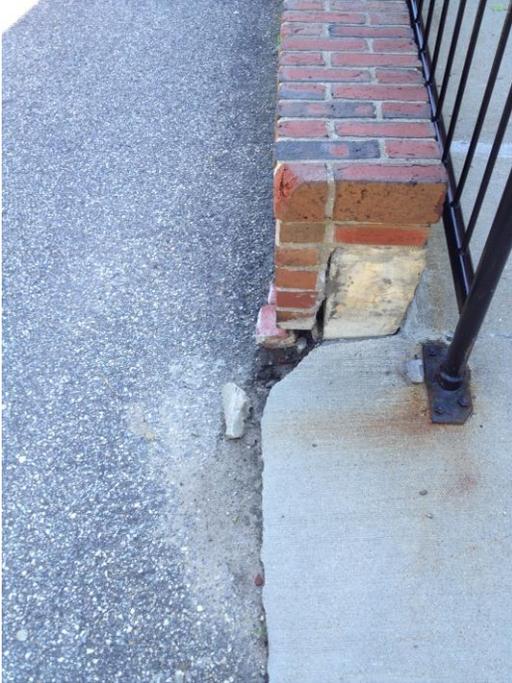
Damaged wall at the north addition

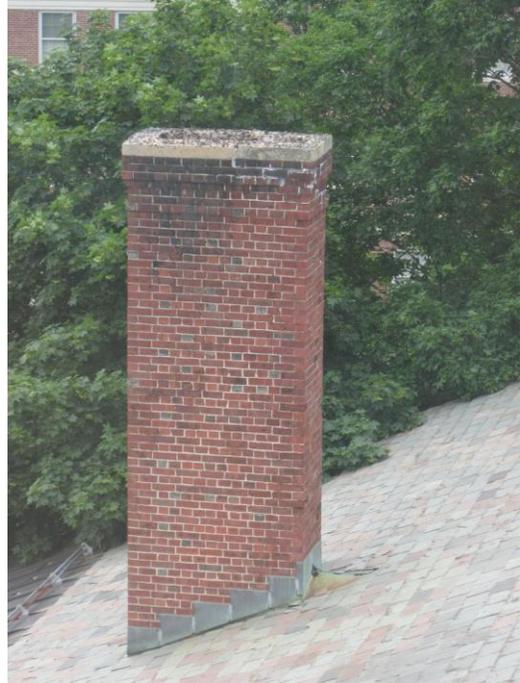
- The chimney appears to be in good condition with the exception of the top few courses of the masonry, which need repointing. The concrete cap is cracked and should be replaced. There are a number of flues inside the chimney that are no longer active. These should be capped off.

Damaged chimney cap and brick joints

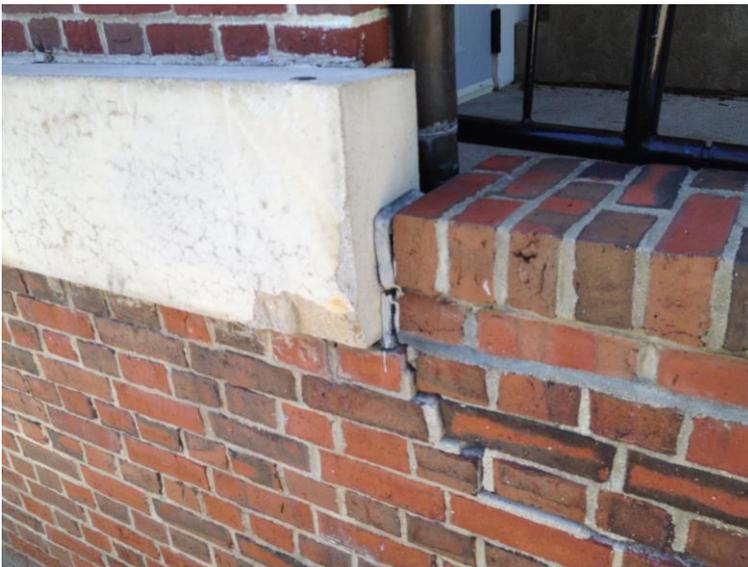
Joint damage at the north addition

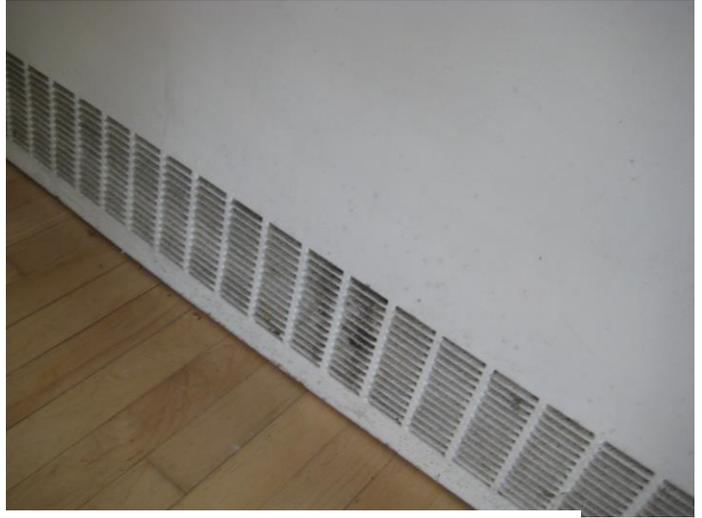
Grilles at Lobby Heater need cleaning

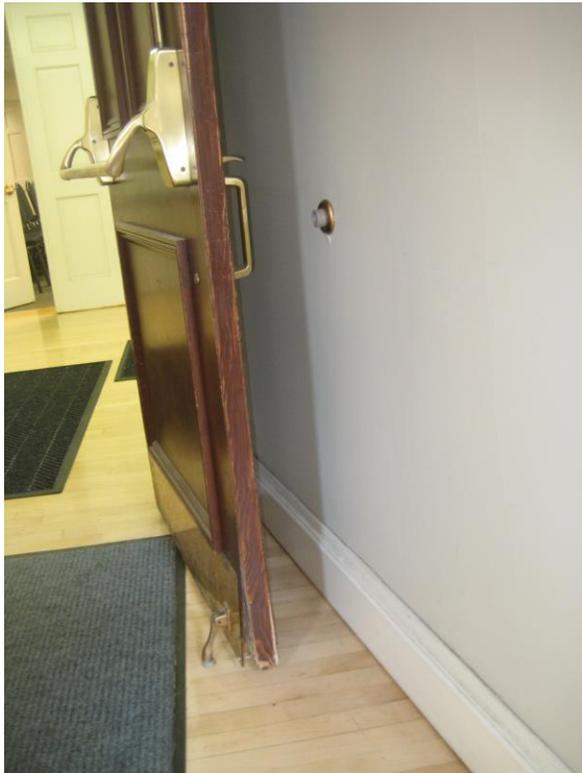
Damaged lower rail at lobby door

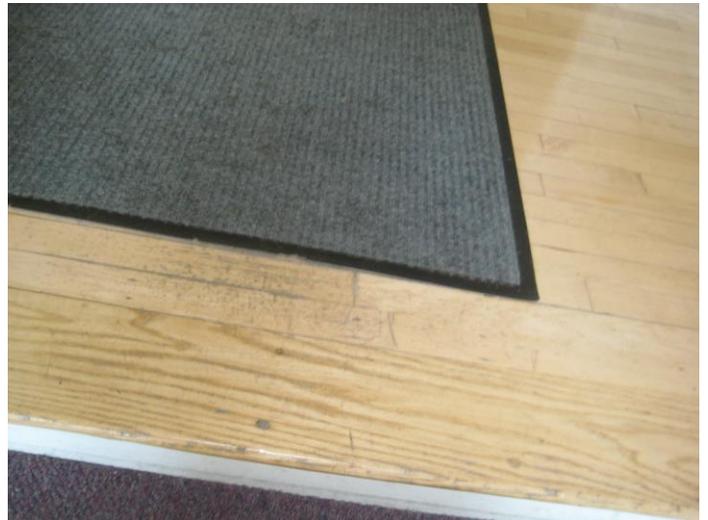
Worn wood flooring at the Entrance Lobby

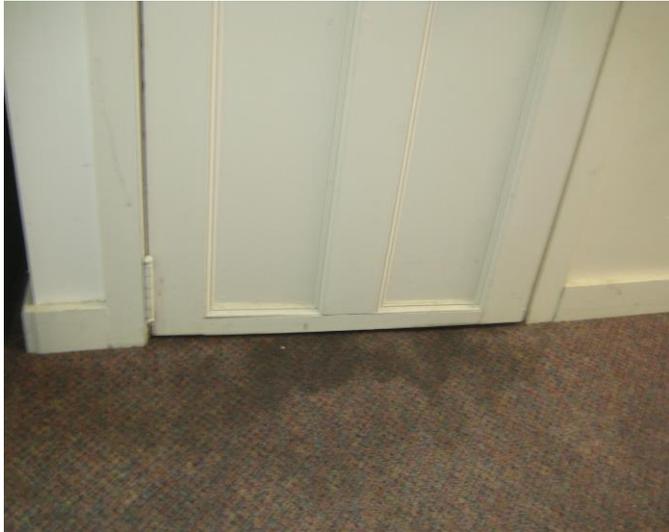
- The painted drywall ceiling, walls and woodwork are in fair to good condition. The carpet has some minor stains in places. The inner vestibule door, door to the stair and the rear exit door are painted metal in good condition. The inner vestibule door does not have a closer. One wall is gouged a bit.

Stained carpet at southwest vestibule

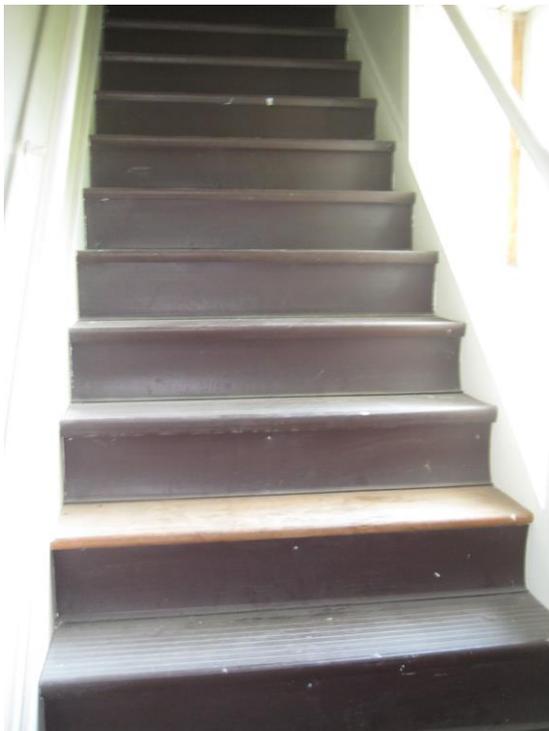
- The painted plaster walls and ceiling, and the painted woodwork are in good condition. The hardwood treads are covered with safety treads that are paint spattered, and one safety tread is missing.

Missing safety tread at southwest stair

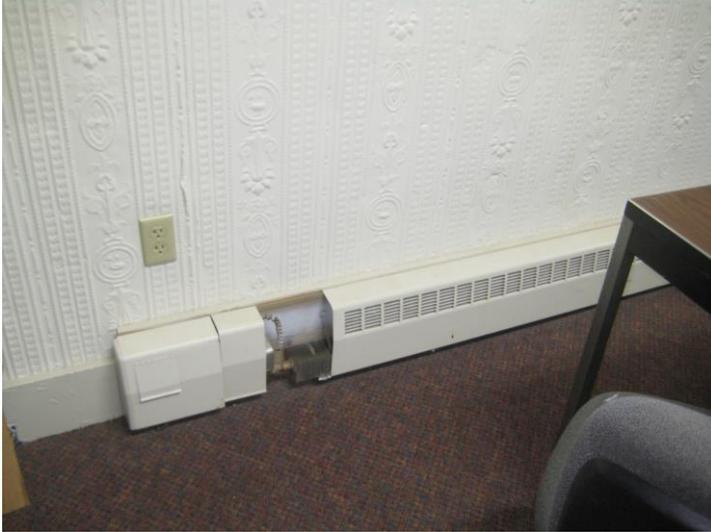
Missing cover piece at baseboard heat in Meeting Room 2

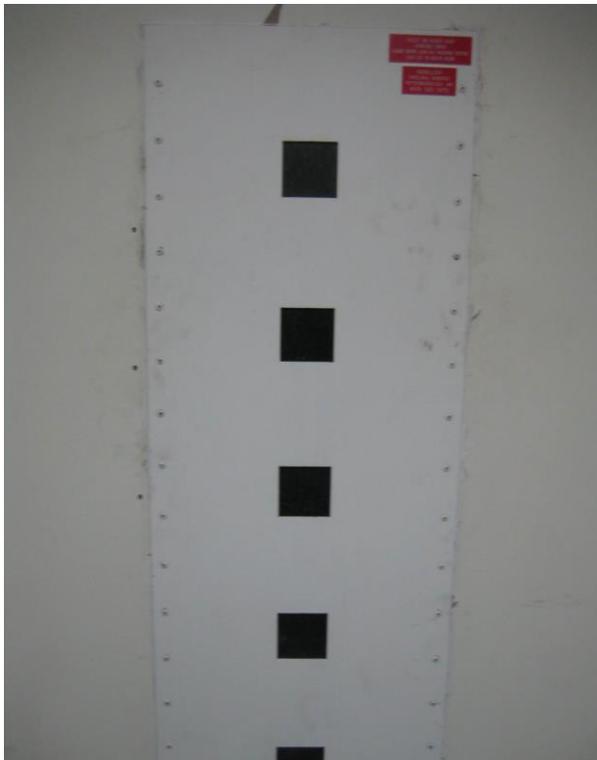
Damaged paint near pellet bin access door

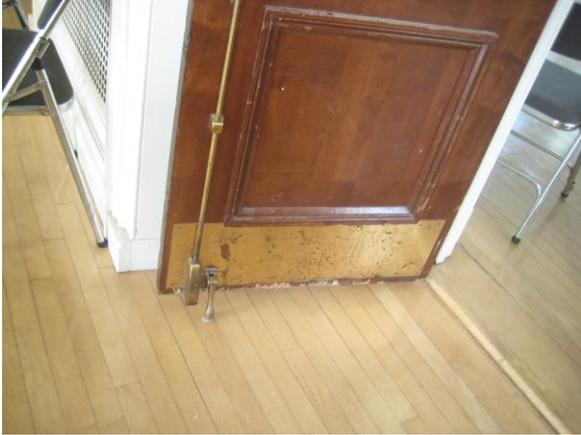
Damaged bottom rail at Auditorium door

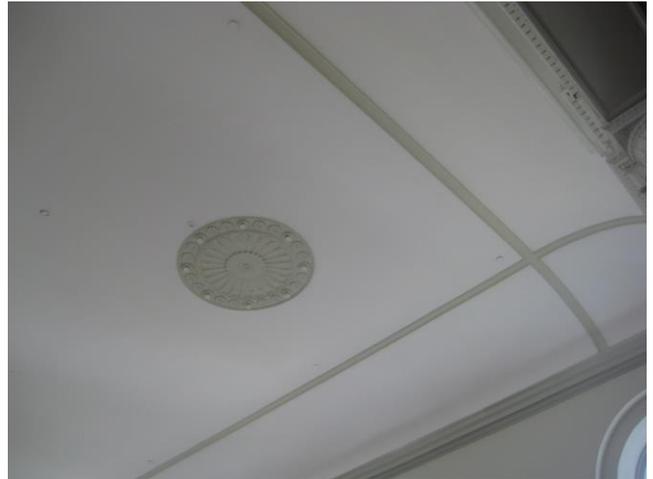
Missing bulbs at ceiling fixture in Auditorium

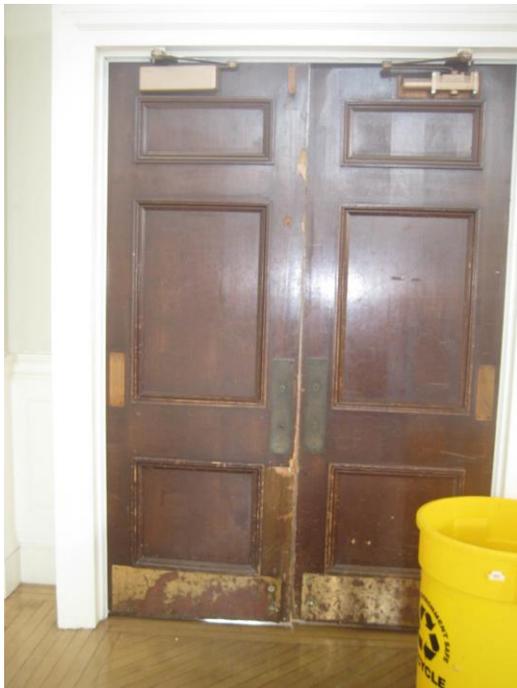
Doors at northwest entrance to Auditorium are not ADA compliant and are in poor condition

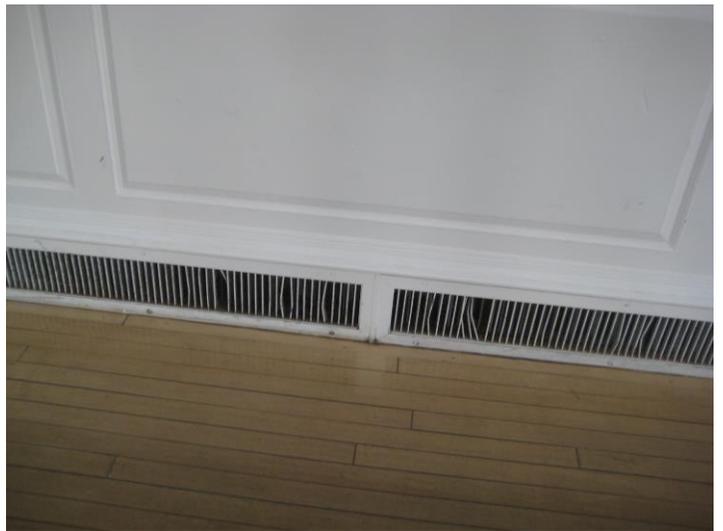
Damaged return air grilles at face of stage

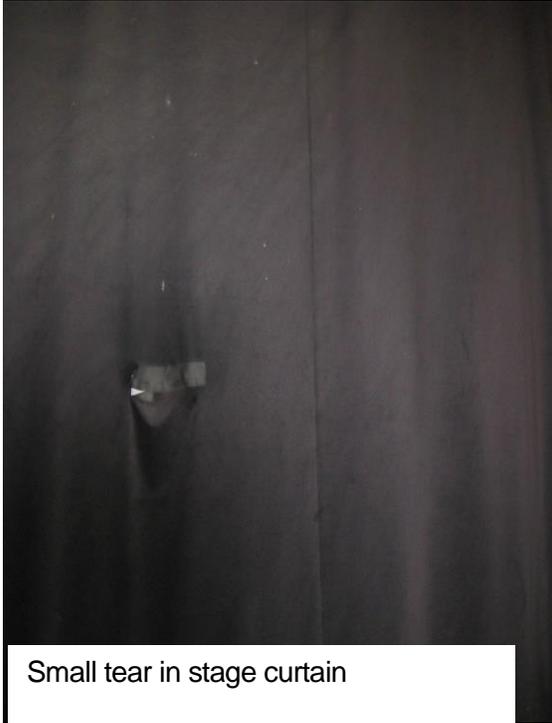
Small tear in stage curtain

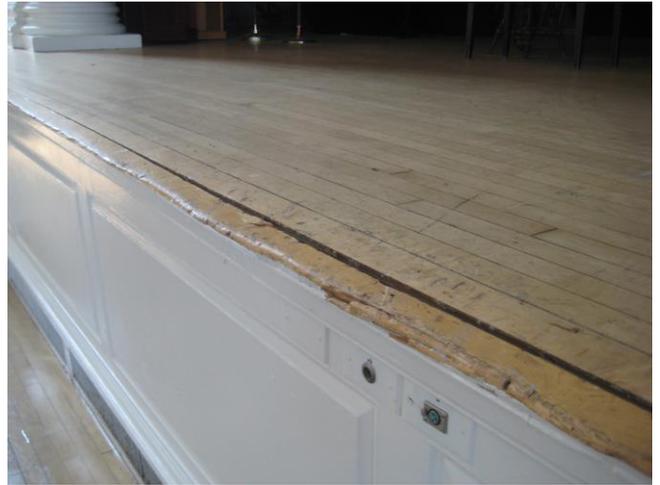
Damaged nosing at edge of stage

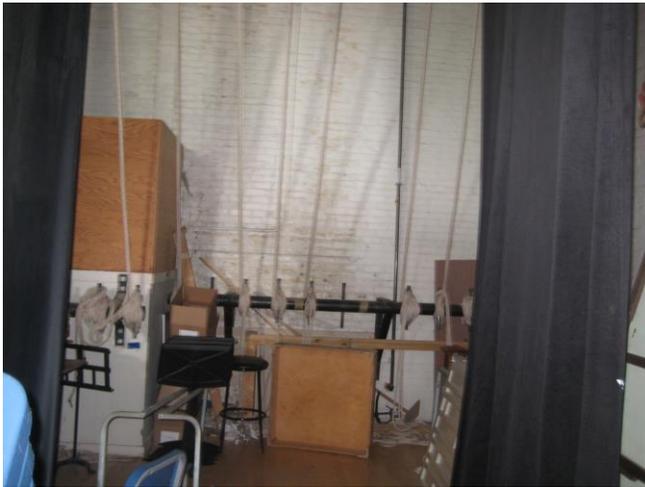
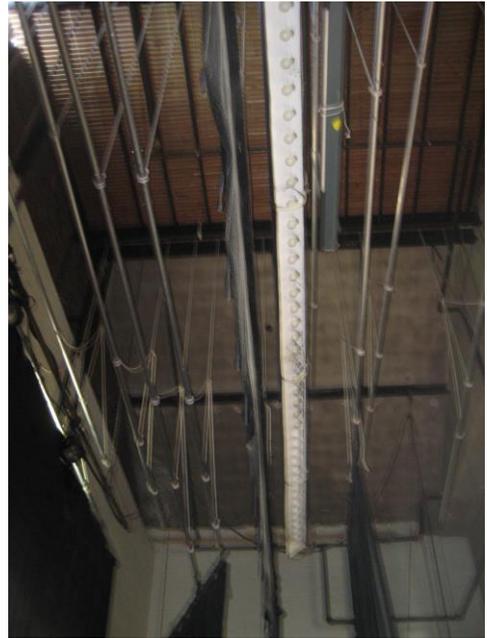
The manual stage rigging is not counterweighted

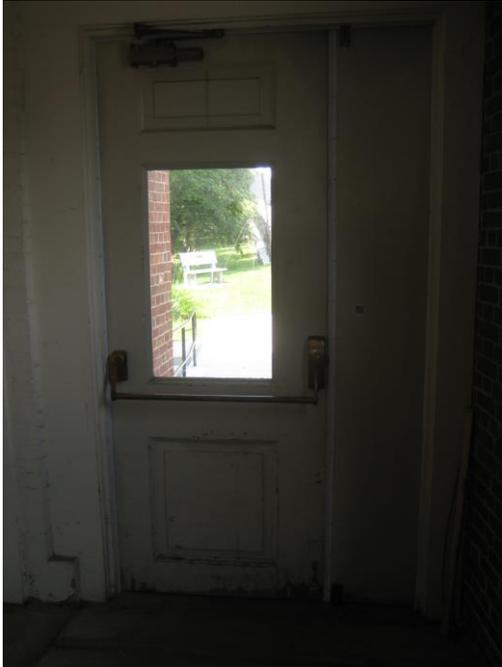
Northwest entry door is in poor condition

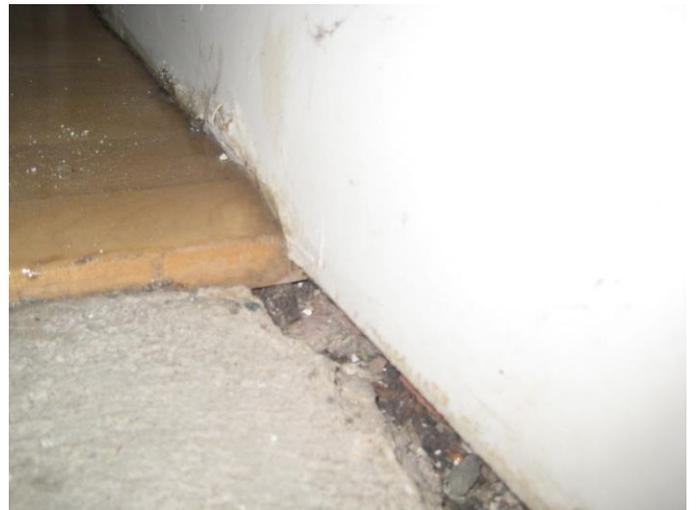
Uneven transition at northwest entry floor

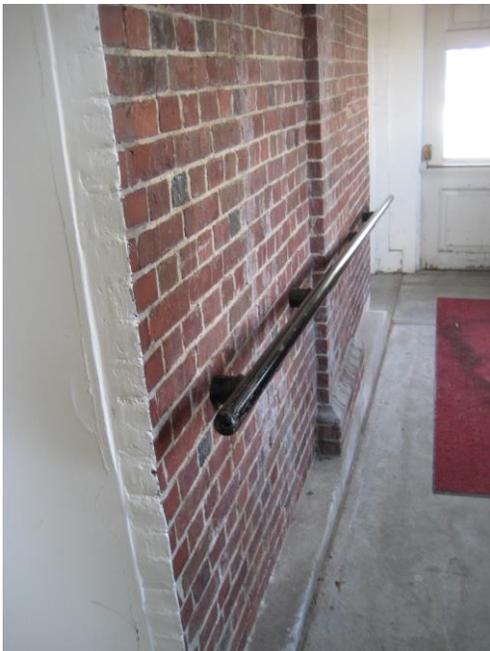
Handrails at northwest entry do not return to the wall

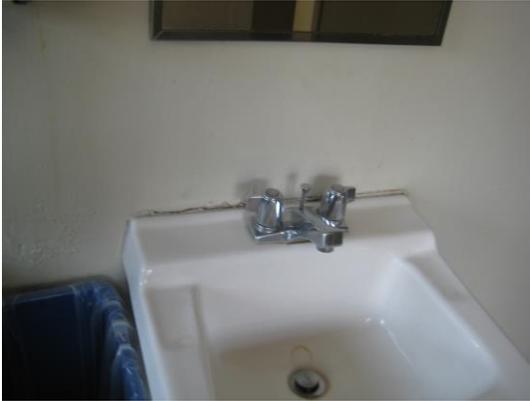
Sink at 2nd floor Women's Room is pulling away from the wall

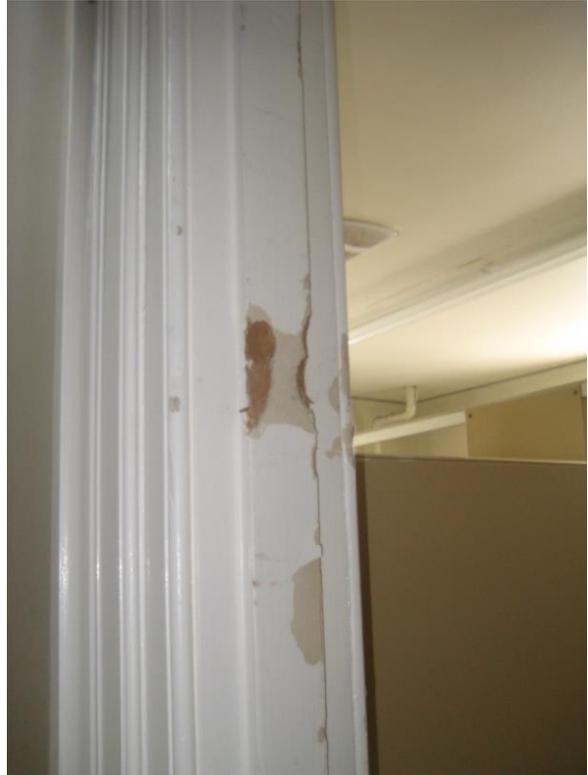
Damaged door frame at Men's Room

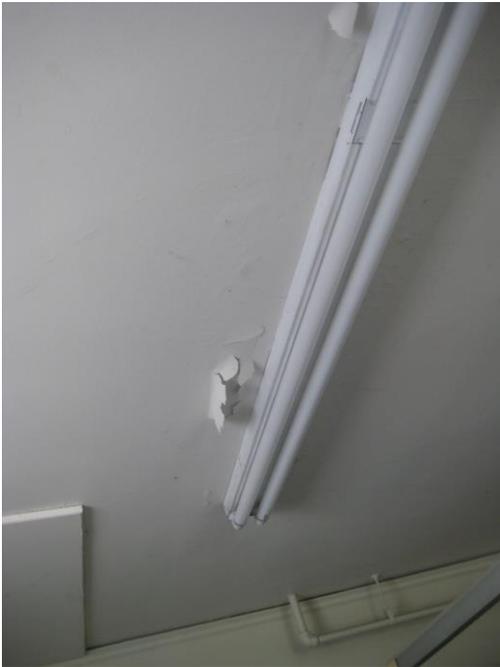
Peeling paint at Men's Room ceiling

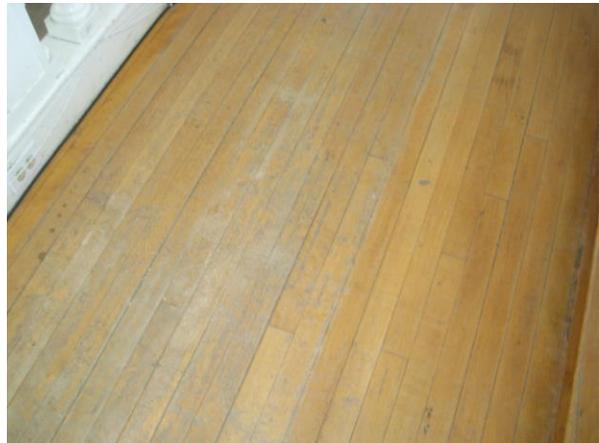
Worn finish on Balcony Floor

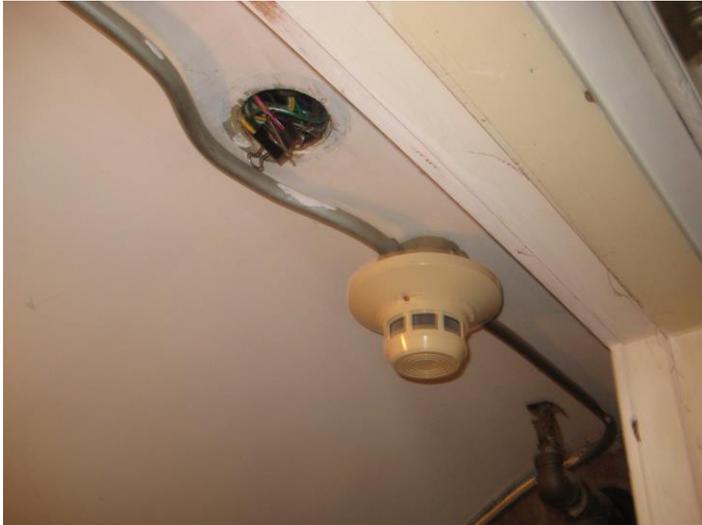
Missing fixture at Basement stair

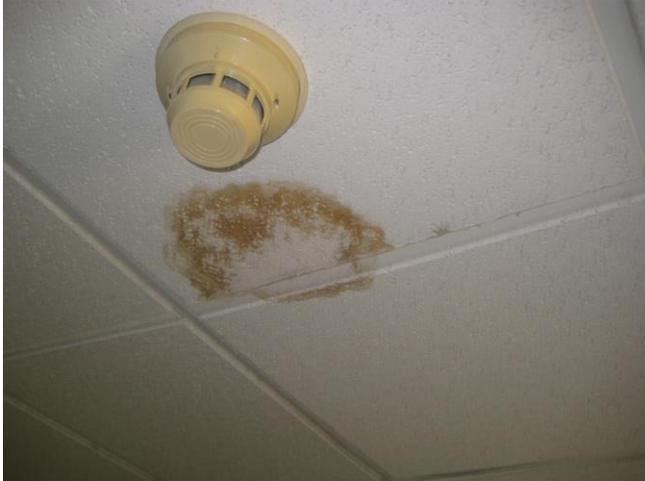
Water damaged ceiling tiles at basement south entrance

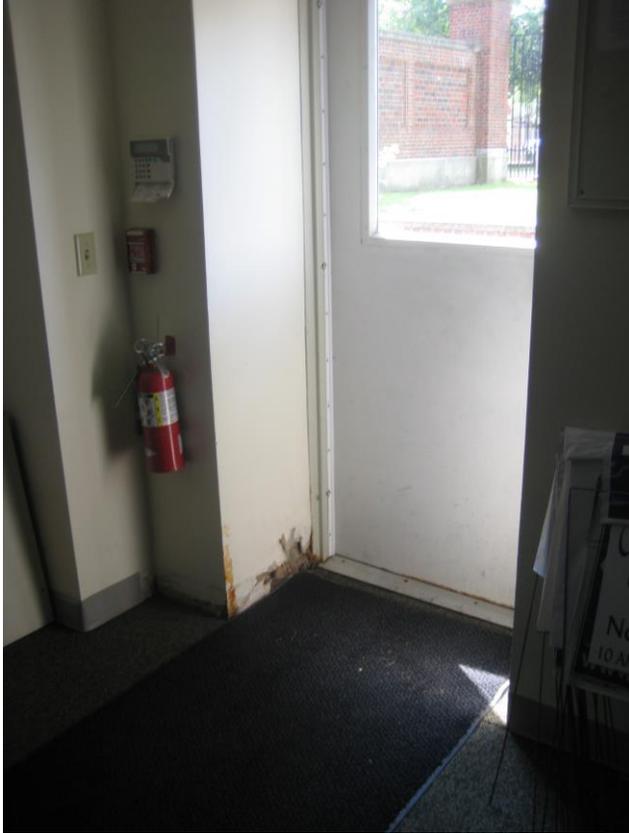
Water damage at basement south entrance

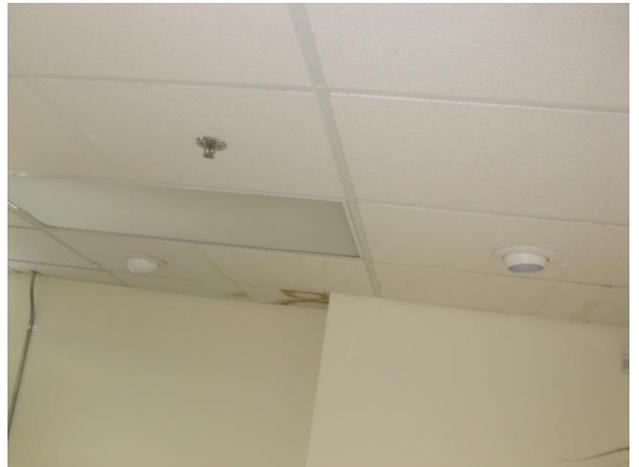
Water damaged ceiling tile in Building Department office
