The Peterborough Town Library Master Plan Study

Peterborough, New Hampshire

June 22, 2004

The Peterborough Town Library
Master Plan Study

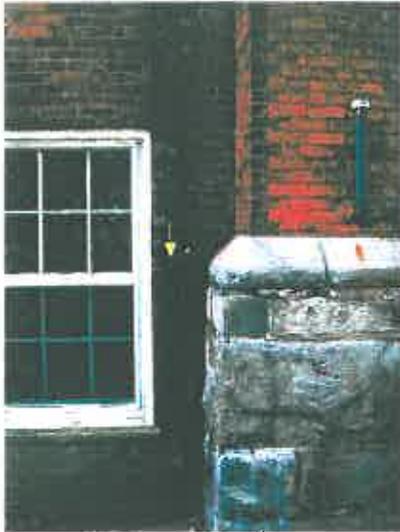
At the rear wall of the building where the 1956 addition joins the original 1892 building, the roof shapes combine with a very short overhang that causes water to flow down the brick wall of the 1956 building. In addition to the moss and algae that has grown on the wall at the water streak location, absorption of water in the brick has caused cracking through the entire thickness of the brick and block wall at the ground floor window. This problem should be corrected so that water flows off the roof without running down the wall face. An extension of the roofing would solve this problem. The roof edge detailing is similar on the opposite side of the building, but the water streaking is not as visible. A similar extension of the roofing material at this second location is also recommended to avoid damaging the brick and block wall.

Photo 12A: Connection of 1956 to 1892 building at west wall (rear of building). Algae and moss to right of window indicate path of water flowing off roof and down the wall face. Brick has horizontal crack at yellow arrow at mortar joint.

| ID | Existing Condition | Proposed Condition | Estimated Cost |
|---|--|--|---|
| S4 | Water damage to rear brick. | Extend roof at this area, clean and repair brick. | \$ 7,500 |

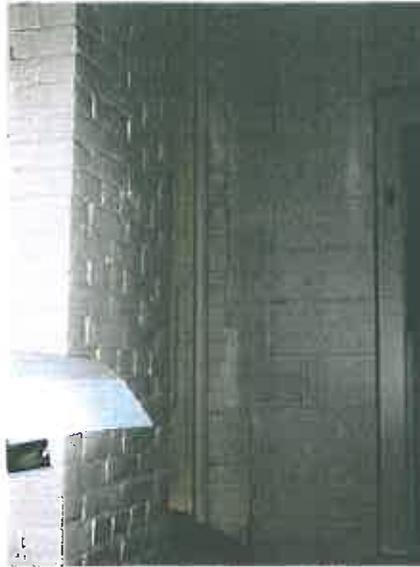
Photo 01: Main floor level, west wall, joint between 1956 and 1892 buildings, where there has been a small amount of movement over nearly 50 years of existence.

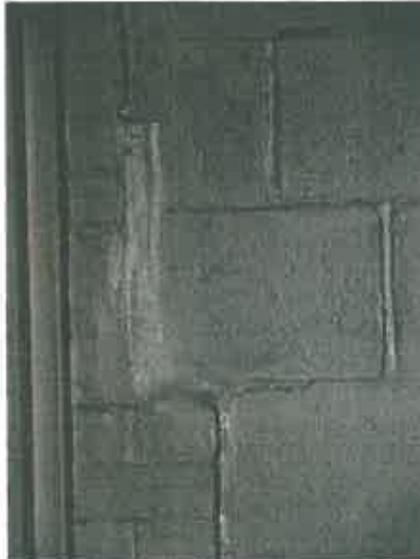
Photo 02: Closeup of photo 01 showing small crack in CMU wall. This joint has a significant amount of water running down the outside face of wall.

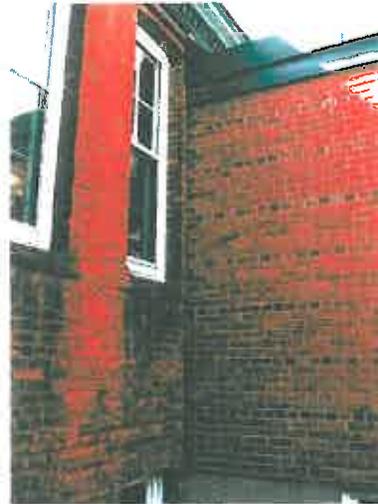
Photo 22: Connection joint of 1978 to 1892 building showing closed joint. This joint has been open in the past as a result of improper caulking of the joint. That has been corrected. Recaulking may be necessary as general maintenance.

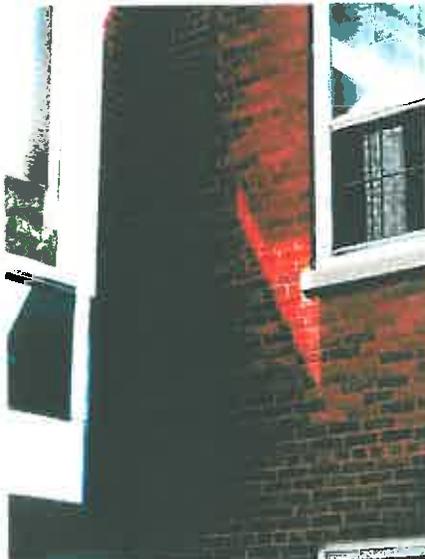
Photo 11: Connection joint of 1978 to 1956 addition showing tight, closed joint 1'-0" right of inside corner. Joint is at upper story level.

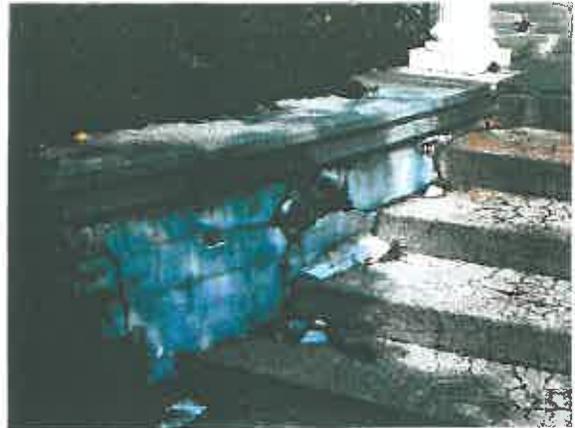
The original front entry to the 1892 portion of the building has severe deterioration of the brick walls which support the roof columns and which form the wing walls on both sides of the stairs leading from the ground surface to the porch level. The brick is spalling and crumbling apart. We recommend that the roof structure be shored in place and the brick walls be removed and replaced. This effort may require removal and replacement of the porch floor and the concrete stairs not only for access but also to gain an entire structure which will have the same approximate lifespan. Interestingly, the entry appears to be an add-on to the original building since it does not appear on the 1892 drawings. We also recommend that the bushes which are located on either side of the stair wing walls be cut back to provide an open air space of at least 18" between the bushes and the walls. These bushes are holding water and moisture in the brick and contributing significantly to their deteriorated condition.

Photo 24: Left wing wall at old entry stairs showing deterioration of brick and stucco overlay on brick.

| ID | Existing Condition | Proposed Condition | Estimated Cost |
|---|--|--|---|
| S3 | The front portico is deteriorated. | Repair/replace front portico. | \$ 37,760 |

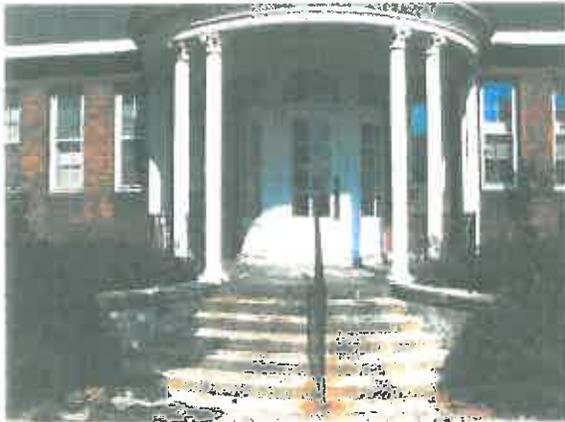
Photo 30: South wall of 1892 building with covered entry. Note shrubs growing tightly around and over the top of the walls on both sides of the stairs.

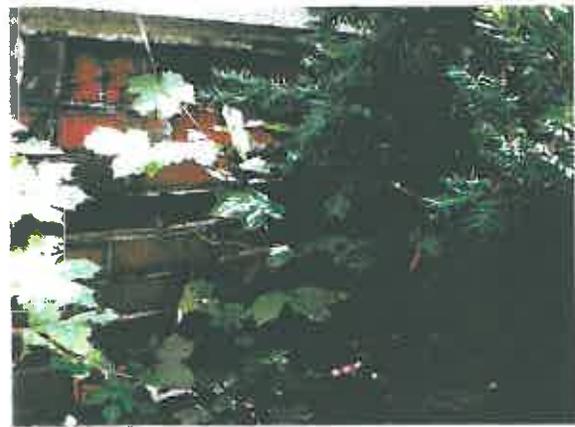
Photo 27: West side of 1892 entry walls showing extreme spalling of brick.

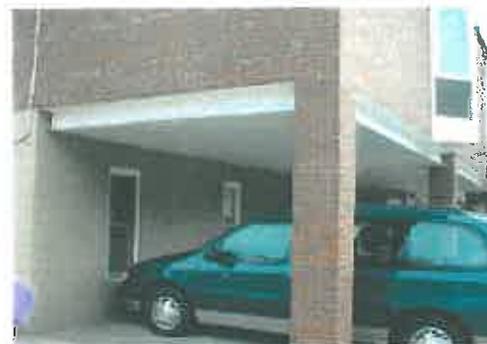
noted support among his peers in the industry for sprinkler systems in libraries, and noted that this was not always the case. Books subjected to water damage can be at least partially preserved with quick drying technologies. We also note that while water can subject collections to damage, sprinkler systems can contain a fire to the area of ignition, and mitigate if not altogether eliminate the spread of fire to an entire facility. In addition to protection of the library's collections, an area of special concern is the overhang on the west side of the building under which vehicles are presently parked. Special arrangements for sprinkling this area should be considered.

**Parking Under Overhang. Fire/Safety
Hazard**

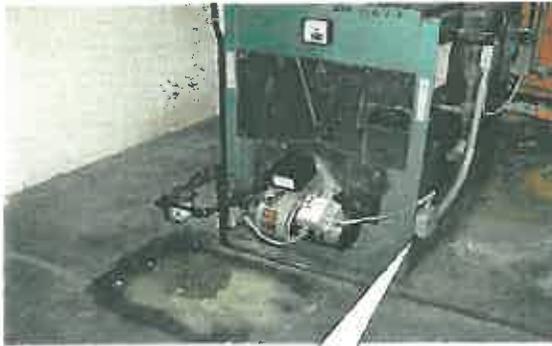
Electrical devices are located on one of the boiler jackets. This is not recommended since it will result in premature failure of electrical devices, and delay repairs to the affected boiler should they be necessary.

1978 Boiler Needs Electric Devices on Jacket.

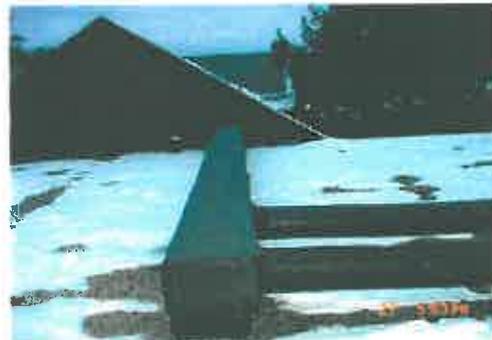
Ductwork serving the Fiction and Children's areas from AHU-1 and AHU-2 is generally as shown on the design drawings, with slight deviations to simplify layout. This ductwork is exposed to the weather elements and deterioration has already started to take place. Joints in the black rubber membrane covering the ductwork have come apart at several locations, most notably where duct supports are in place. The covering has fallen away from the bottom of several sections of duct, exposing the rigid fiber board insulation (and smaller sections of bare duct) to the weather elements. A metal 5 gallon tar roofing pail is in place in one location to support ductwork in lieu of a duct support. Two ~12' sections of 10" round duct do not have an intermediate support. The main duct trunks between the attic and where ductwork penetrates the roof is rectangular, and covered with a black

rubber membrane. Round ductwork is recommended, since it does not permit water to pool on top of the duct. Internally insulated, spiral ductwork is more effective than the black rubber covering, since it will reflect radiant heat better than the black rubber membrane installed.

Rectangular Rooftop Ductwork

| ID | Existing Condition | Proposed Condition | Estimated Cost |
|---|--|--|---|
| M10 | Exterior ductwork for delivering air conditioning has failing insulation and is prone to collect precipitation. Energy and system efficiency is compromised. | Replace exterior rectangular ductwork with round style, internally insulated, with reflective metallic exterior surface. | \$ 11,800 |

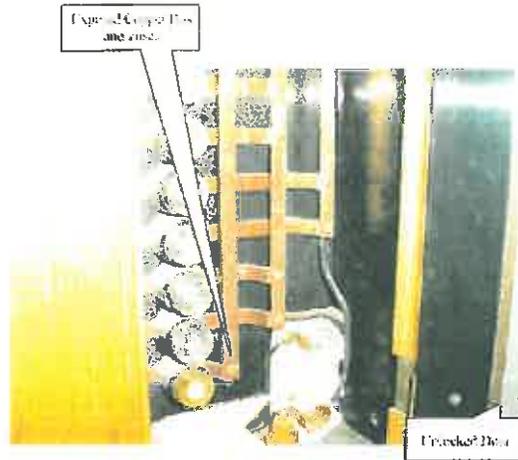
The panel is unlocked in a publicly accessible corridor. One breaker position (41) is missing and has been taped over with electrical tape. A legitimate circuit breaker panelboard filler should be provided at this location.

Dangerous Panel

| ID | Existing Condition | Proposed Condition | Estimated Cost |
|---|--|--|---|
| E12 | Old, wood door panel not locked, public access; exposed buses. | Lock immediately; replace panel ASAP | \$ 800 |

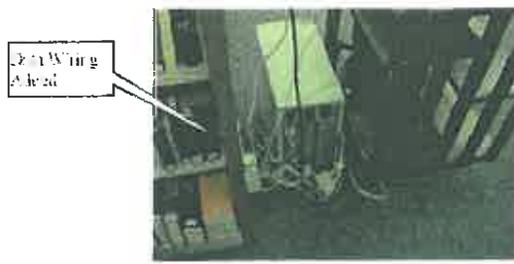
Exposed Wiring

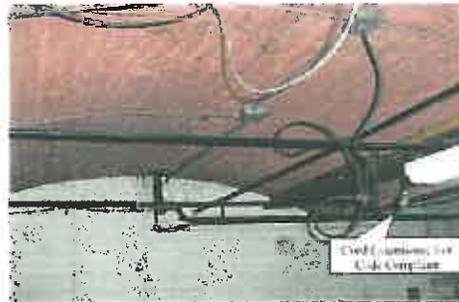
Improper Wiring

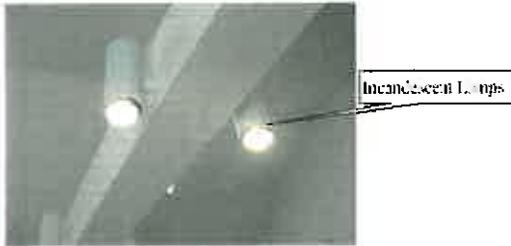
Inefficient Lighting

Lighting throughout should be replaced with quality direct/indirect fluorescent lighting with electronic ballasts and T8 lamps.
