Characteristics of Existing Public Works Building

Building and Fire Codes

Primary Building Systems

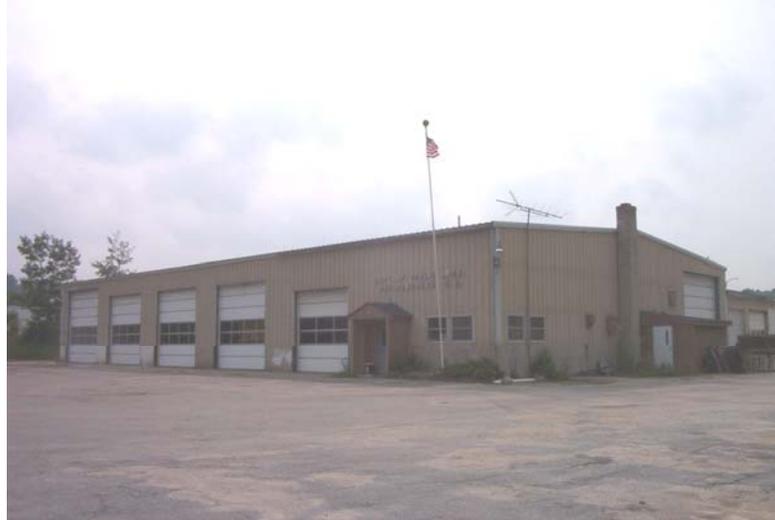
Figure 19 Existing Public Works Facility

The current facility occupied by the Peterborough Department of Public Works was built in 1970, after the Town was given the land by the Goyette family for a Town Barn in 1969. The facility has served the town for over 35 years, but now is too small and in need of repair. The location, at Evans Flat⁶, maybe difficult to expand further due to wetland considerations reflected in the town master plan (Refer to Figure 19).

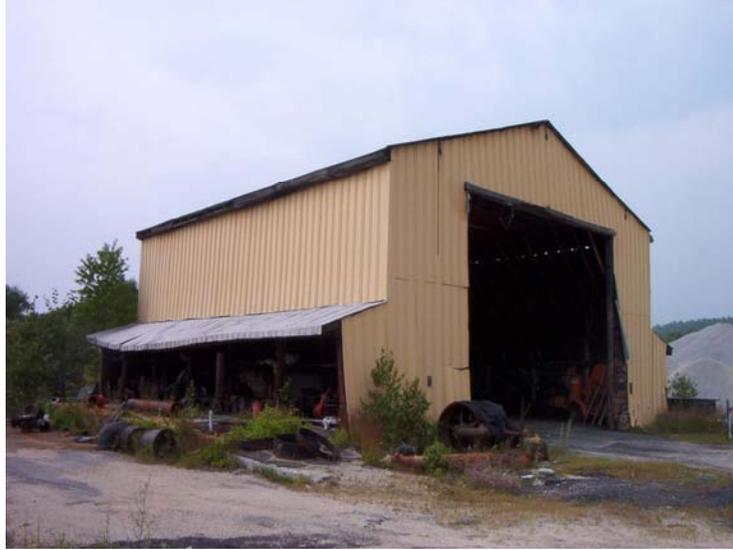
Figure 20 – Dilapidated Storage Shed

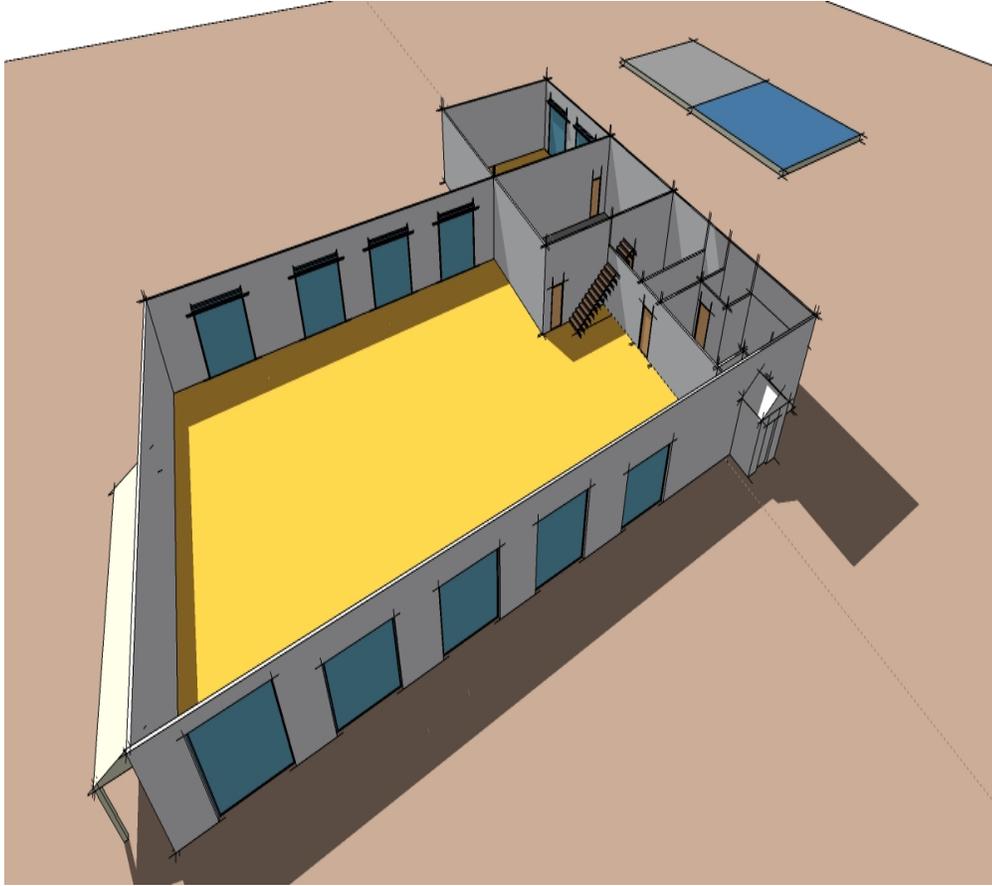
Figure 21 - Existing DPW Building Layout

The current facility (Refer to Figure 21 below) occupied by the Peterborough Department of Public Works contains approximately 10,441 net square feet primarily on one floor, though a small mezzanine is available. About 95% of the net floor space, or 9,908 square feet, is directly used for specific functions for vehicle storage, equipment repairs, staff areas and storage.

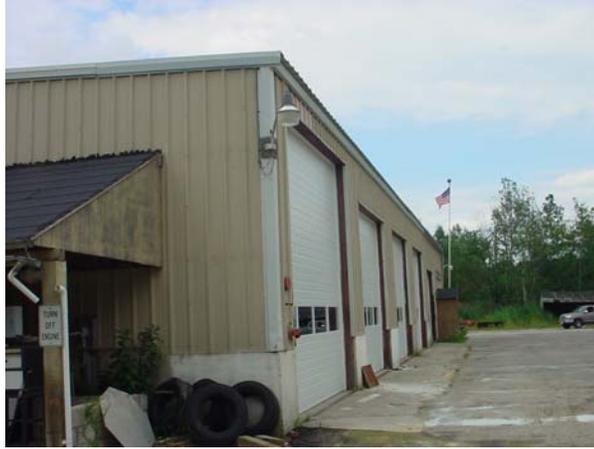
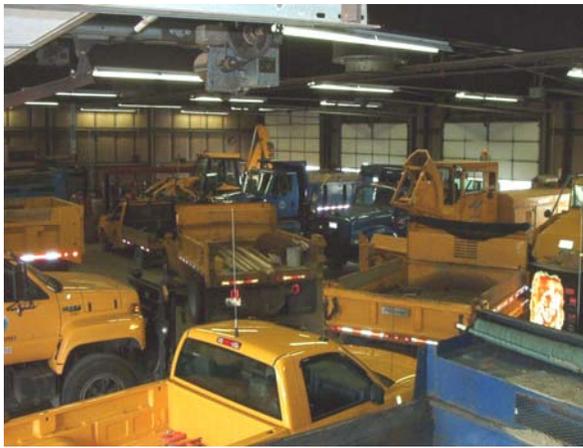
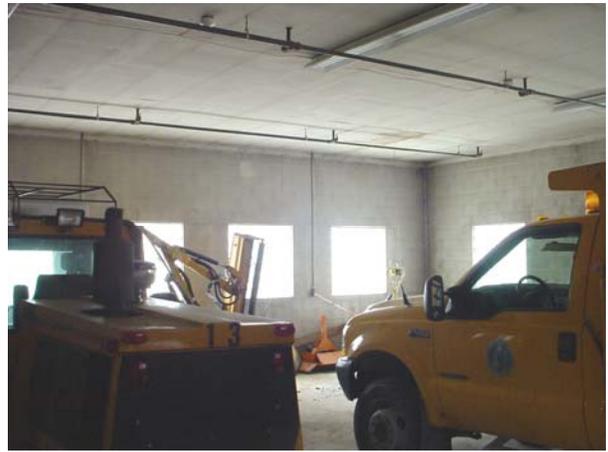
Figure 22 - Interior of Existing Vehicle Garage

- Adequate space for equipment storage
- Adequate supply storage
- Additional vehicle bays
- On site parking for 30 vehicles
- ADA – men and women toilet rooms
- Adequate space for employee lunch room, lockers and meeting space (expanding staff)

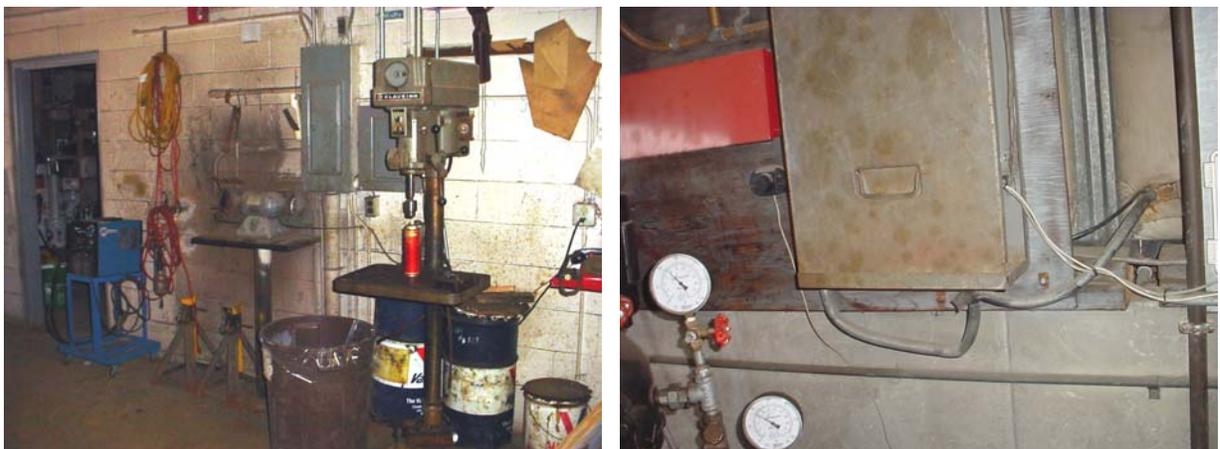
Figure 23 Existing Electrical Distribution Systems

Distribution panel boards located in the shop/repair area, which are wall mounted, presently have other equipment located in front of the panels, and therefore do not comply with current NEC code (Refer to Figure 23).

Ground fault circuit protection for receptacles located in the garage area need to be retrofitted or replaced with ground fault protection for personnel safety and NEC codes. Some conduit work needs to be reattached or re-supported in compliance with current NEC codes.

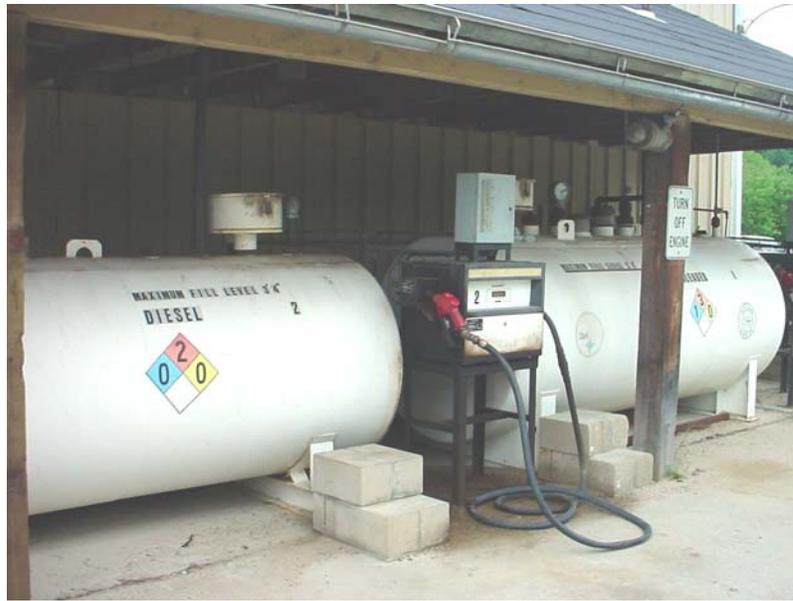
Figure 24 Existing Oil Fuel Tanks

Four 270 gallon (nominally 1,000 gallons total) above ground diesel tanks (Refer to Figure 24 on the next page), located adjacent to the unrated exterior shed, provide a minimum fuel supply for the facility and town uses. Greater storage capacity, perhaps 4,000 to 5,000 gallons, would allow the Town to take advantage of larger 'drops' and bulk fuel prices from vendors. Similarly, should the Town try use of biodiesel; the minimum delivery quantity is 4,000 gallons. (Appropriate containment features will be needed with bulk storage tanks.)

- Additional Garage Space for town vehicles
- ADA – Install horn and strobes per current NFPA 72 code requirements
- Increase Capacity of Fuel Dispensing Tanks – provide spill contaminant protection
- At least one bulk storage tank (4,000 gallon minimum) at cost of \$40-\$50,000

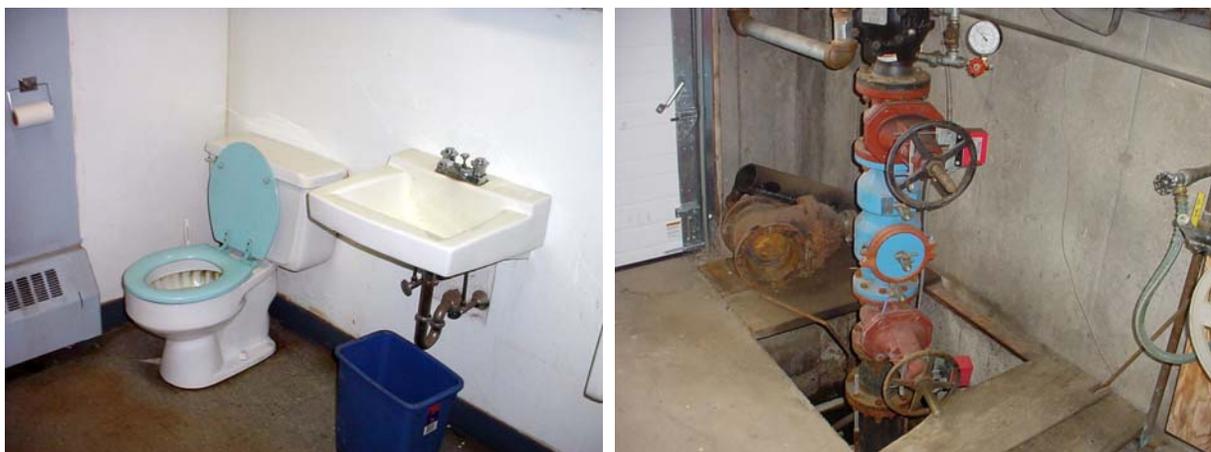
Figure 25 – Existing Plumbing Fixtures and Sprinkler Riser

Existing plumbing fixtures do not comply with ADA requirements and are in poor condition. Currently, the existing kitchen sink has been used as a janitor mop sink; this violates building codes. The building is served with a combination sprinkler and domestic water service entrance. The building has a 1 inch domestic water service and a 6 inch sprinkler main. Backflow prevention is not provided (Refer to Figure 25).

Building is fully sprinklered with a complete system and has a wet type alarm valve. (Refer to Figure 25).

- Upgrade exterior lighting to provide coverage to support night time activities
- Ground fault circuit protection located in the Garage
- Replace existing plumbing fixtures
- Provide backflow prevention for existing sprinkler and domestic water service
- Install a janitor room with a dedicated mop sink

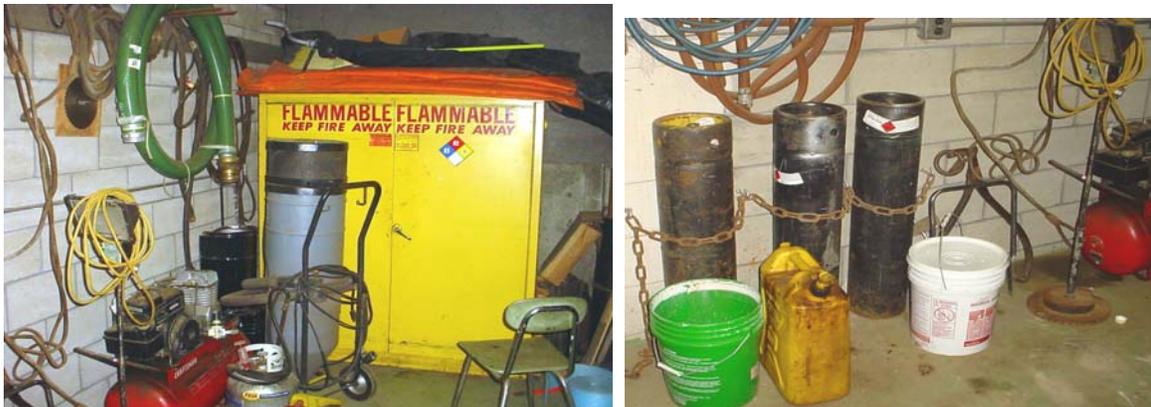
Figure 26 - Existing Hazardous Materials Storage

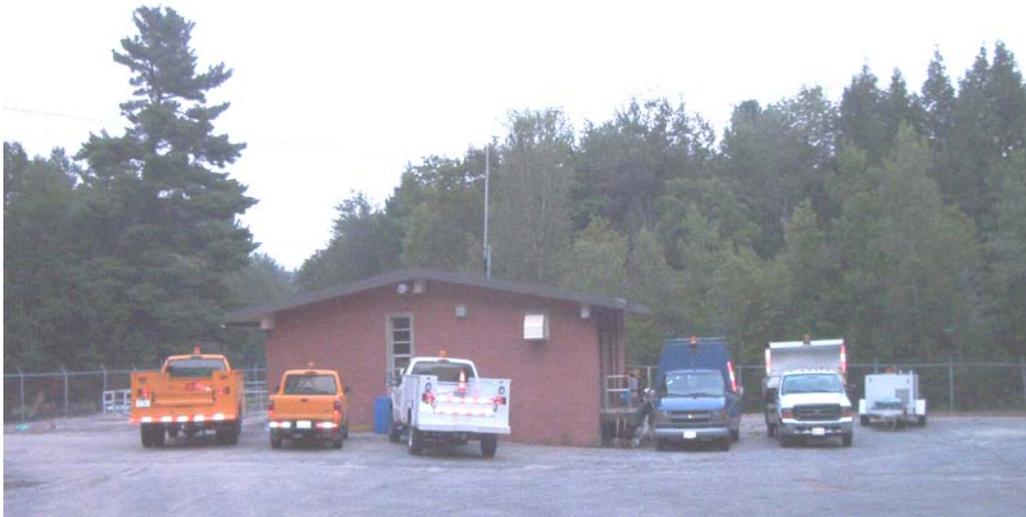
Figure 27 - Existing Waste Water Treatment Plant

The current facility occupied by the Peterborough Waste Water Department, as part of the Public Works Department, was built in 1971 (Refer to Figure 27). The Director of Public Works has stated the current facility will need to be replaced in the near future in order to meet state standards.

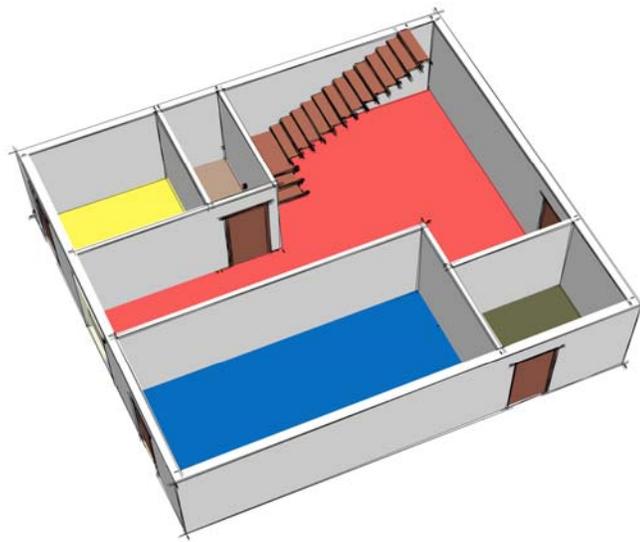
Figure 28 Existing Floor Plan Waste Water Treatment Plant

The current waste water facilities, including storage at the Hunt Road Building and garage space at the current police garage, contains approximately 2,855 net square feet. About 70% of the net floor space, or 2,800 square feet, is directly used for specific functions for pump and well equipment, electrical transformers, lab and lunch room, staff areas and storage (Refer to Figure 28 on the next page).

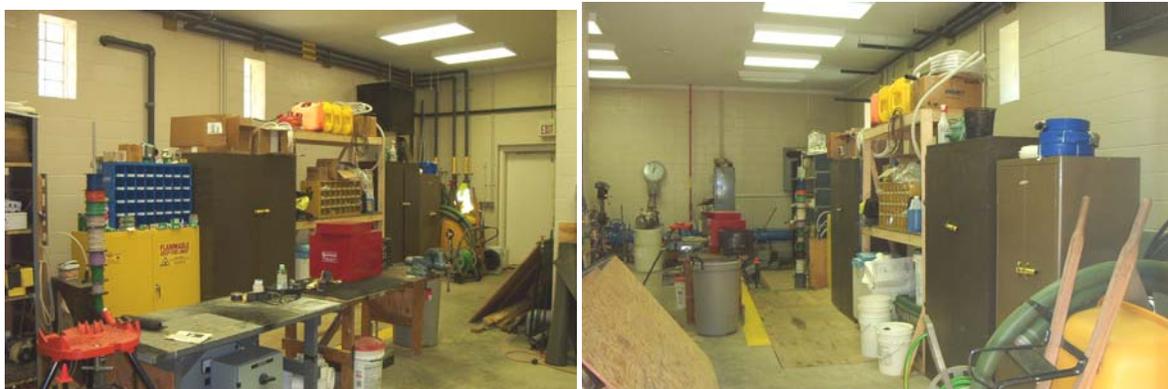
Figure 29 - Existing Storage Facilities

- Staff lockers and shower room (employee health)
- Adequate administrative work space and storage for current and future staff
- Covered garage storage for (6-8) vehicles (protection from the weather)
- Centralized storage of equipment and supplies (staff efficiency)
- Ability to expand facilities as future growth in town services occurs
