### Department Description

### Characteristics of Recreation Main Offices

### Characteristics of Existing Pool Building

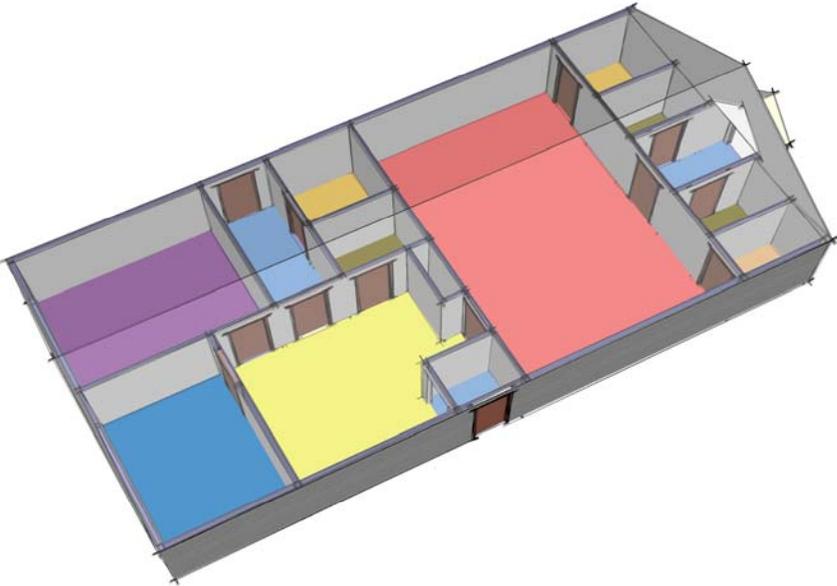
Figure 31- Existing Floor Plan Beaver Jutras Recreation Building

The Beaver Jutras Recreation Building used by the Peterborough Recreation Department was built in 1995 as a relatively small and economical structure to provide for both office needs and meeting space (Refer to Figure 31). The location of the building and the adjacent storage shed prohibits the expansion of ball fields on either side of the building.

The Main Recreation Building occupied by the Peterborough Recreation Department dates from 1995 and contains approximately 1,600 net square feet on one floor. About 91% of the net floor space, or 1,466 square feet, is directly used for specific functions for public use, administrative, conference room, public toilets and storage. The balance of the area is circulation space and mechanical rooms. Refer to Facility Needs Assessment by Department for a complete breakdown of space by specific function.

The current facility will need to address the following design issues in order to effectively administer a community recreational program as outlined by the director:

- Adequate indoor program space to accommodate new programs
- Storage space for outdoor equipment, vehicles and weather sensitive supplies

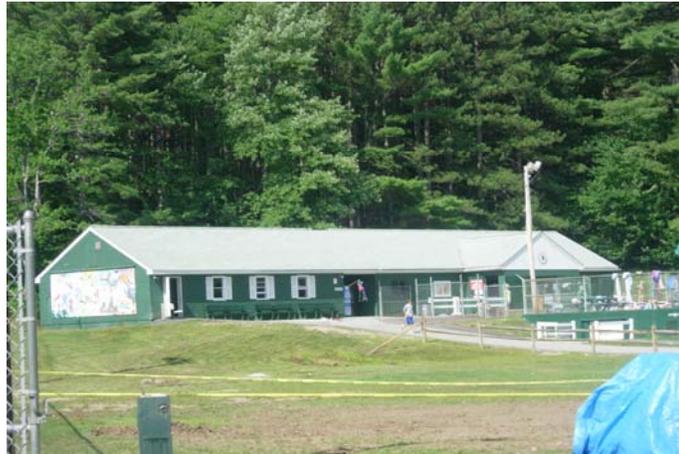
Figure 33 - Existing Arts and Crafts / Bath House Facilities

The in ground public swimming pool was built in 1936. The current Pool Building was built in the late 1950's to replace the original, and renovated in 1993. The building is used by the Peterborough Recreation Department as a multi purpose building. The building contains approximately 2,740 net square feet on one floor. Half the building is used year-round for Arts and Crafts and other programs. The other half is not used in the winter when the pool is closed (Refer to Figure 33 and Figure 34).

About 95% of the net floor space, or 2,375 square feet, is directly used for specific functions. The Arts and Crafts portion of the building contains 1,152 square feet for recreation along with public toilets, snack bar and storage. The remainder of the building is the Bath House with public toilet rooms/showers, changing rooms, and storage. The balance of the area is circulation space and mechanical rooms. Refer to Facility Needs Assessment by Department for a complete breakdown of space by specific function.

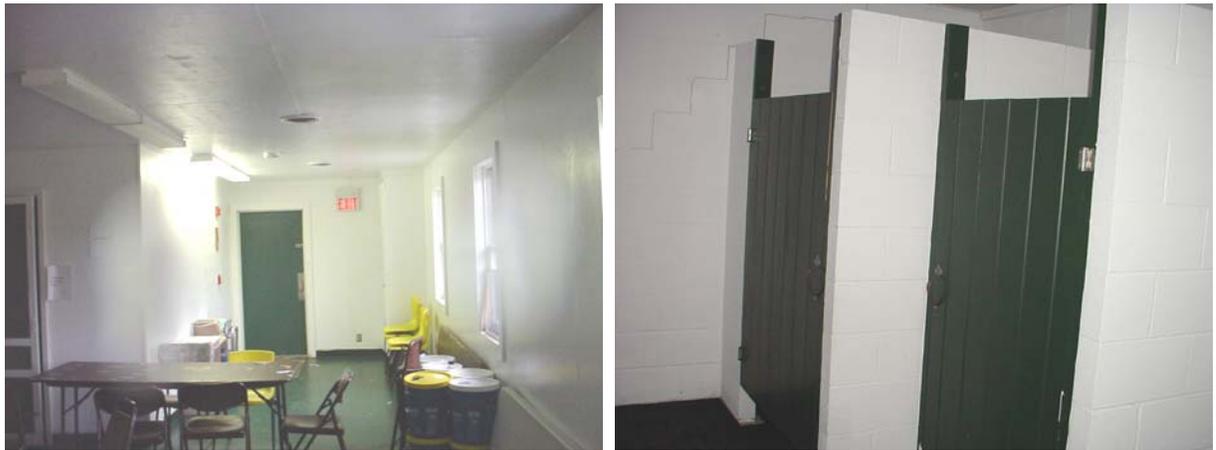
Figure 35 - View of Existing Arts & Crafts Area and Toilet Rooms

Fixtures in Men and Women public toilet rooms, located in the Arts and Crafts portion of the building, are tank type water closets and wall hung lavatories. Fixtures appear to be in good condition and ADA compliant. However, toilet fixtures in the Bath House are non compliant with ADA requirements (Refer to Figure 36 above).

Current lighting throughout the facility is typically surface mounted wrap around style fixtures in fair to poor condition and should be replaced.

Current heating and ventilation system is limited in the Arts and Crafts portion of the building and should be replaced. There is NO heating system in the pool Bath House.

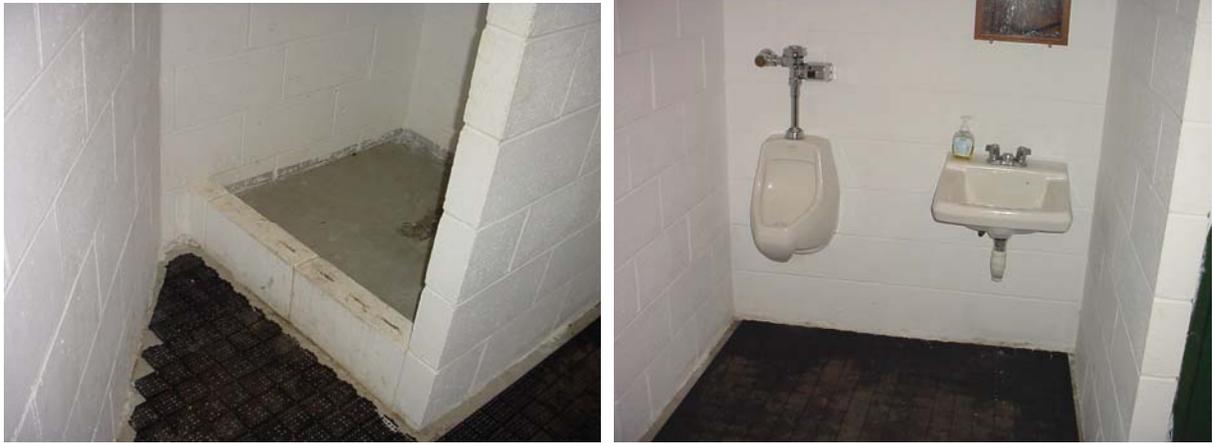
Figure 36 - View of Existing non ADA compliant Plumbing in Bathhouse

Pool's locker and shower rooms do not comply with current ADA regulations (Refer to Figure 36 above)

- New athletic fields properly sized for competitive competition
- Adequate reception area
- Indoor program space
- ADA – provide full compliance with access requirements for pool facilities with ADA standards
- Life Safety – install complete fire alarm system at Pool
- Replace existing HVAC and ventilating system at Pool building

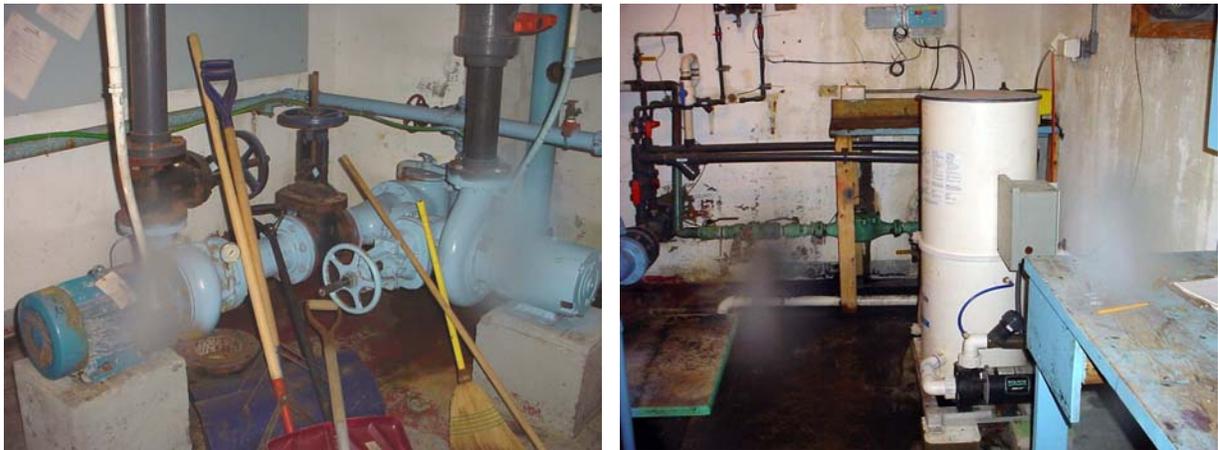
Figure 37 - Existing Pump Room and Pool Equipment

Pool's underground pump room was constructed in 1936 and has outlived its useful life in context with today modern pool equipment (Refer to Figure 37 below).

The in-ground swimming pool, and underground pump room, which were officially opened in 1936, have all outlived their useful life in comparison with today modern pool equipment, facility design and ADA Guidelines. The last major equipment installation dates from 1965.

- Space for future recreation staff when programs are expanded
- Additional athletic fields
- Indoor field facility complying with contemporary standards
- Upgrade and repair existing swimming pool
- New Arts and Crafts/Bath House facility
