# Peterborough Municipal Facilities Needs Assessment & Feasibility Study

Submitted November 15, 2005

Weller & Michal Architects Inc.  
222 West St.  
Keene, NH 03431

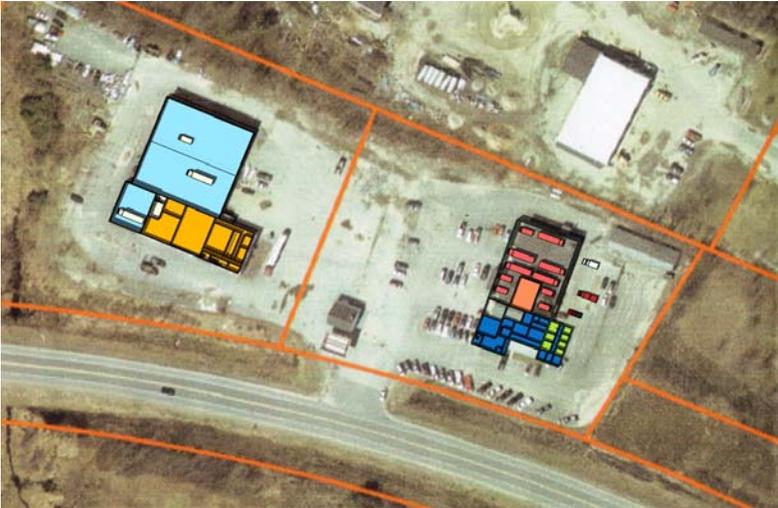
The Town should seek to acquire both the existing Armory site and the former car dealership on Elm Street. This would allow the most flexible use of the Evans Flats area, without constraining options. Alternatively, consider the frontage along Route 101, as shown in Figure 2 – Municipal Facilities Option 2

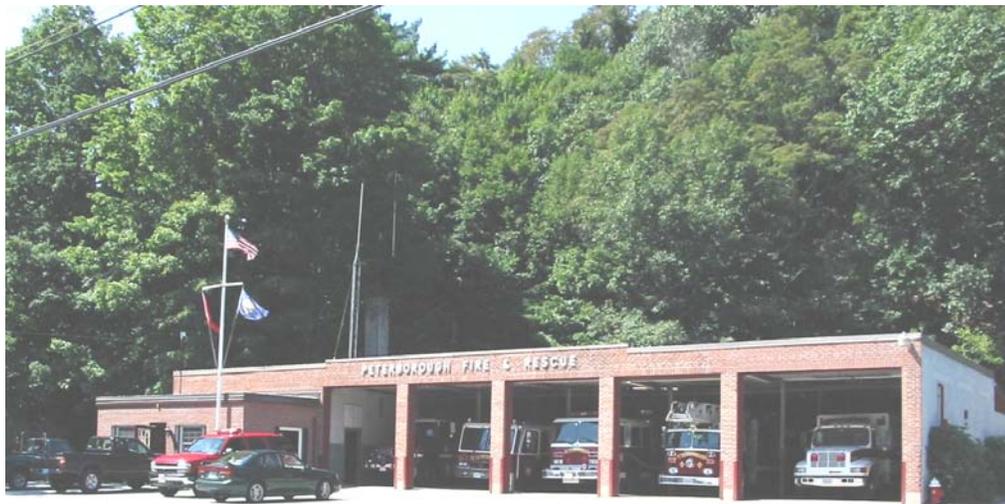
Figure 3 - Existing Fire & Rescue Department

The current brick masonry building has several deficiencies which impact the efficient operation of the department. Primary complaints include the lack of office space, inadequate sized apparatus bays to accommodate larger vehicles, equipment storage areas without proper ventilation, lack of secured storage rooms and inadequate areas for maintenance, and the need for modern restrooms and shower facilities. There is also no space for a dedicated Emergency Operations Center (EOC). Currently, the Fire Chief serves as the Emergency Management Director for the Town of Peterborough.

Current building does not present any major code violations or areas of concern which impact life safety and/or egress code requirements.

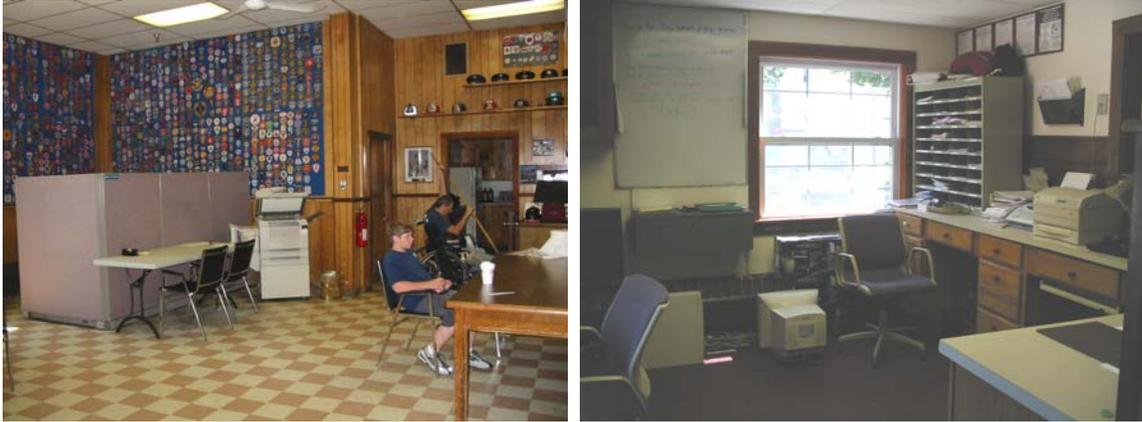
Figure 7 - Interior Views of Existing Fire Station

The current facility lacks key design requirements and amenities necessary for a modern fire and rescue department (Refer to photos shown in Figure 5 and Figure 7). These Include:

- ADA – Install new toilet and shower rooms to comply with ADA standards
- Energy Efficiency/Human Comfort – new HVAC distribution and control system
- Life-Safety Code – new fire alarm system
- Life Safety Code – replace existing wiring within the apparatus garage to comply with current codes

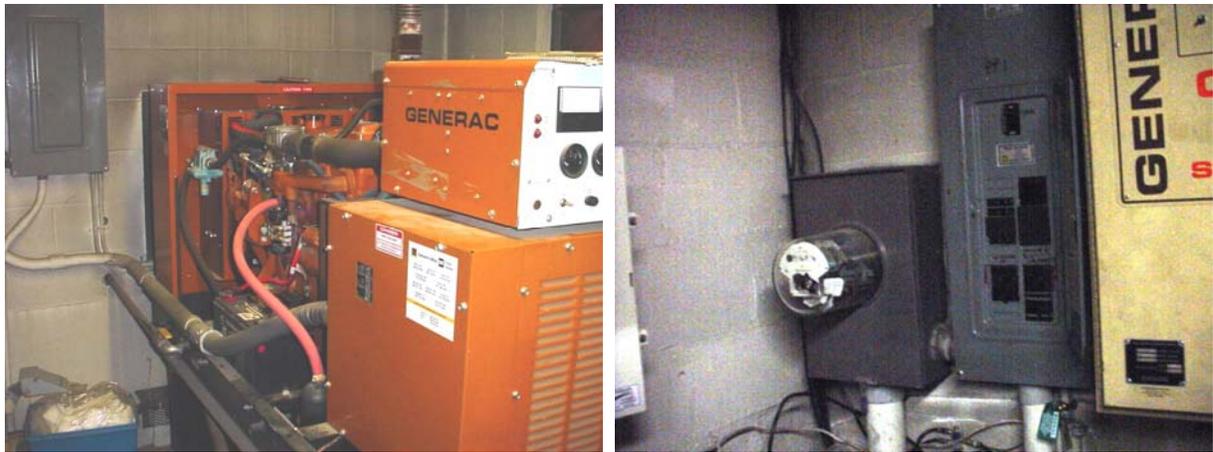
Figure 8 - Existing Stand-By Generator & Distribution System

Standby generator (120/208 v, 3 phase) is new within the past 10 years and appears to be in good condition. Breaker rating is 25 KVA with a 90 amp, 3-pole breaker. Currently the generator capacity is adequate to serve the fire station's current needs under present loading. However, the generator would unlikely support additional equipment or air conditioning if the facility was expanded (Refer to Figure 8).

- Exterior – window replacement
- Safety - space for new SCBA and related equipment
- Equipment Replacement - replace existing 25 year old Stand-by-Generator to handle additional capacity
- Apparatus Garage – expand and modernize facility

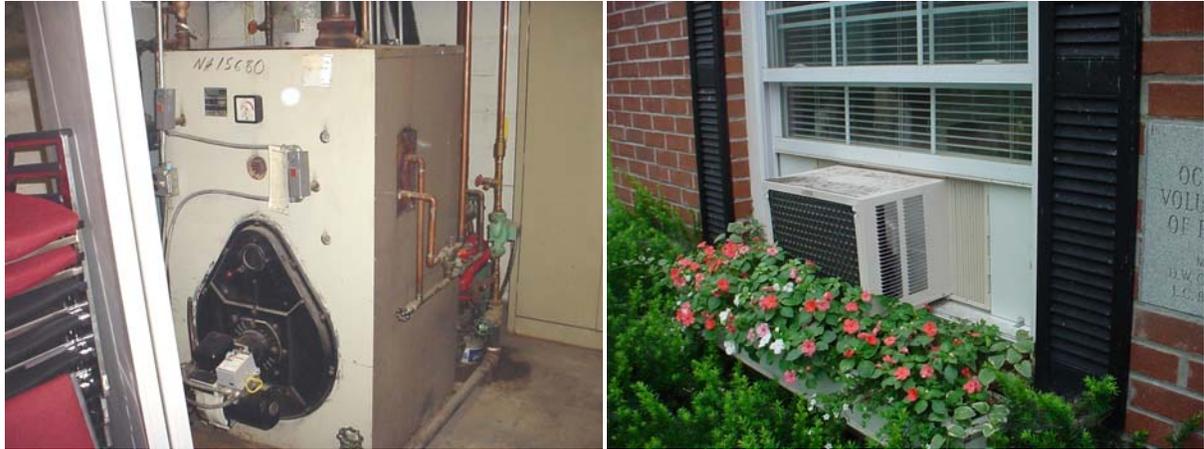
Figure 9 - Existing Heating/Cooling Systems

The primary heating plant is an oil fired American Standard cast iron boiler, 786 MBH, which appear to be in fair condition (Refer to Figure 9).

Kitchenette area is provided with a residential style appliances and residential type hood which is not NFPA compliant.

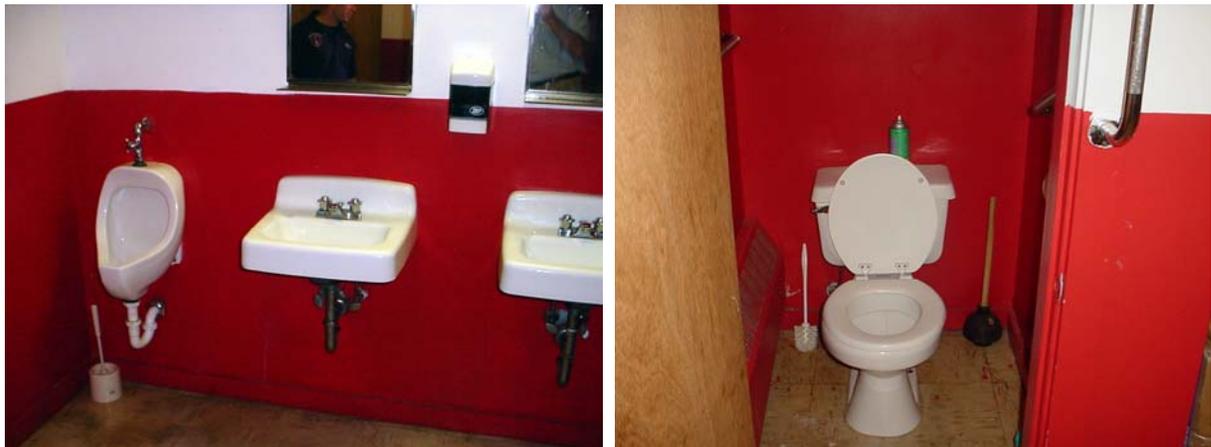
Figure 10 - Existing Plumbing Fixtures

Fixtures in fire fighter's locker rooms are in poor condition and non compliance with ADA regulations (Refer to Figure 10).

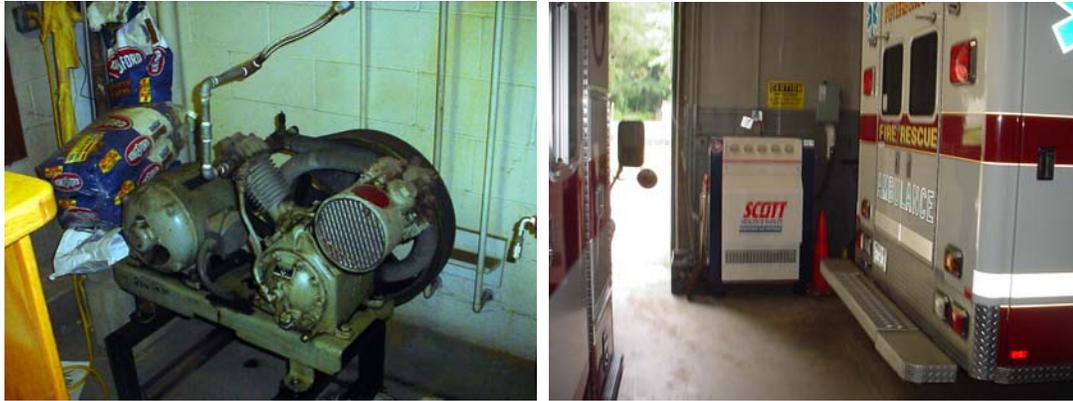
Figure 11 - Existing Air Compressors

Existing air compressor, which supplies air for fire trucks air breaks, is an antiquated unit and should be considered for replacement.

A new and separate air compressor is located in the Apparatus bay/garage for providing fresh air to firemen air backpacks. The compressor is new and in good condition. However, its location may allow for diesel fumes to be introduced into the compressed air (Refer to Figure 11).

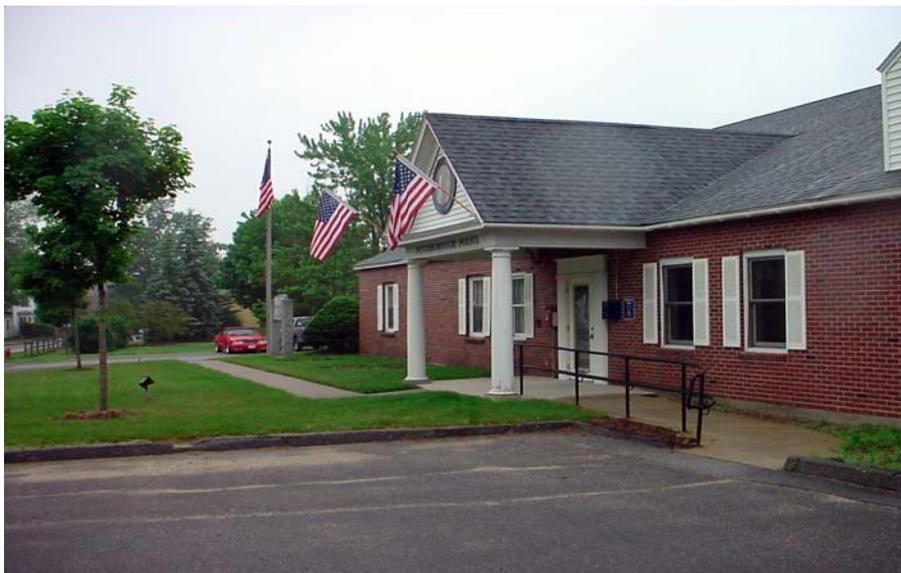
Figure 13 - Visitors' View of Existing Police Station

The current facility occupied by the Peterborough Police Department was formerly the PSNH office building, which was built in 1964. The Police Department moved in approximately 10 years ago (1995) following extensive renovations to convert the building for police use (Refer to Figure 13).

The current building does not present any major code violations or areas of concern which impact life safety and/or egress code requirements. However, not all aspects

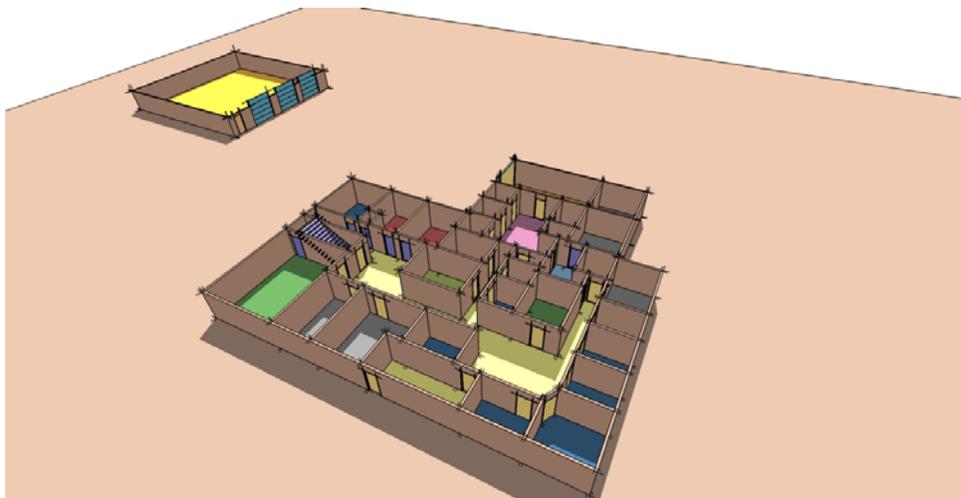
Figure 14 - Existing Police Department Layout

The current facility (Refer to Figure 14) occupied by the Peterborough Police Department contains approximately 6,850 net square feet on two floors. About 82% of the net floor space, or 5,614 square feet, is directly used for specific functions for public use, administrative and record keeping, police officers work areas, training, toilet rooms/showers, holding cells and archive storage.. The balance of the area is circulation space and mechanical rooms. Refer to Facility Needs Assessment by Department for a complete breakdown of space by specific function.

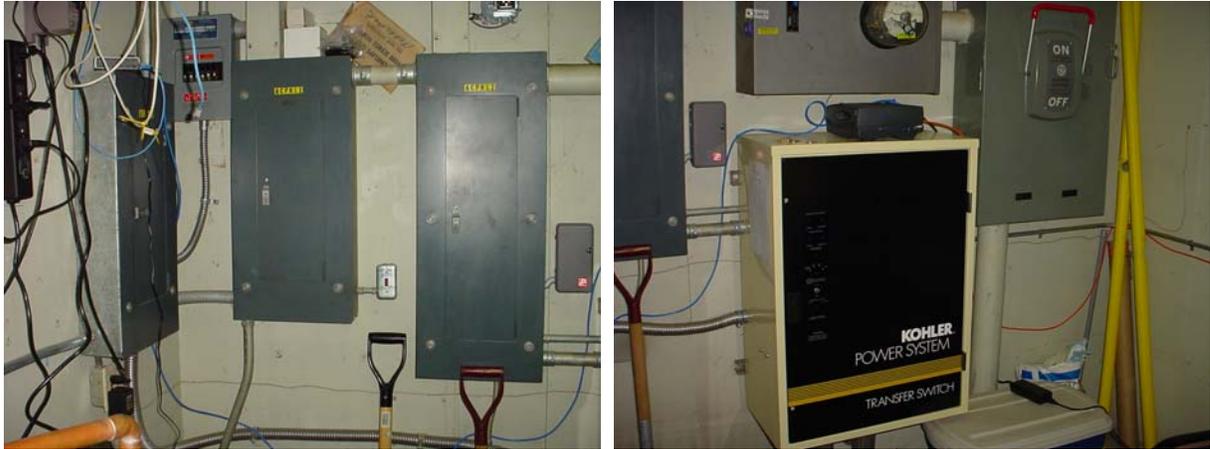
Figure 15 - Existing Electrical Panels and Emergency Power

Replacement of an older GE panel boards should be considered as part of any major renovation or expansion (Refer to Figure 15 on the next page).

Building is provided with a standby propane gas fired generator, Kohler 20 KW unit that appears to be approximately 10 years old. Equipment appears to be in good condition. However, the enclosure has been severely damaged by snow plowing operations and should be repaired as soon as possible.

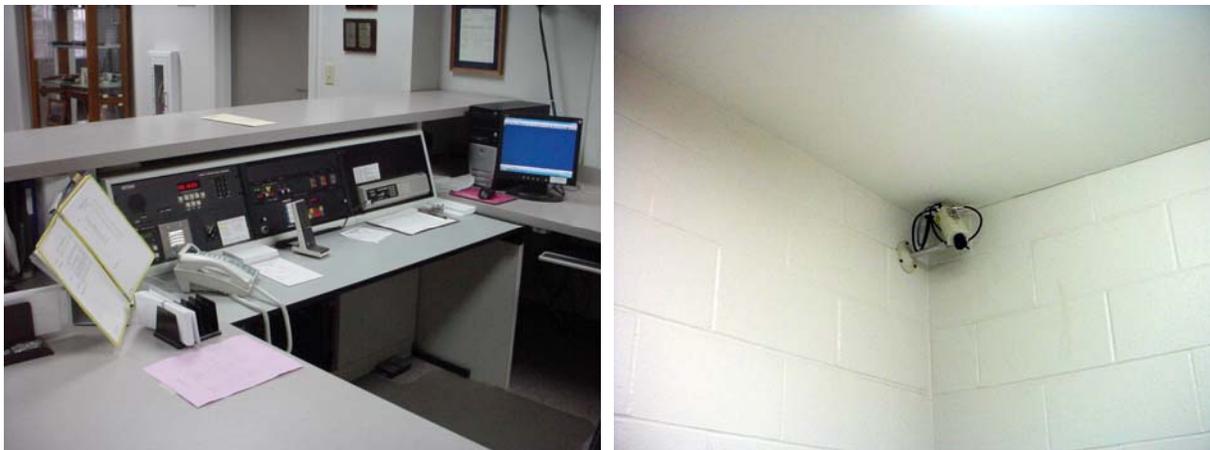
Figure 16 - Existing Communication System & Security at Sally-Port

The current dispatch and control center operates from 8 am to 12 pm and is not a 24 hour / 7 days per week 911 dispatch center (Refer to Figure 16).

The camera system in the Sally-Port and holding cell area is not operational and needs to be replaced.

- Additional space for 24 hour dispatch (police and fire) which will require new equipment and personnel
- Adequate separation of aggressive persons from the remainder of the prisoner population
- Separate area for juveniles from the adult population as required by state law
- Repair damage to standby generator enclosure
- Additional archive record storage area for 700 letter size files per year
- Security cameras

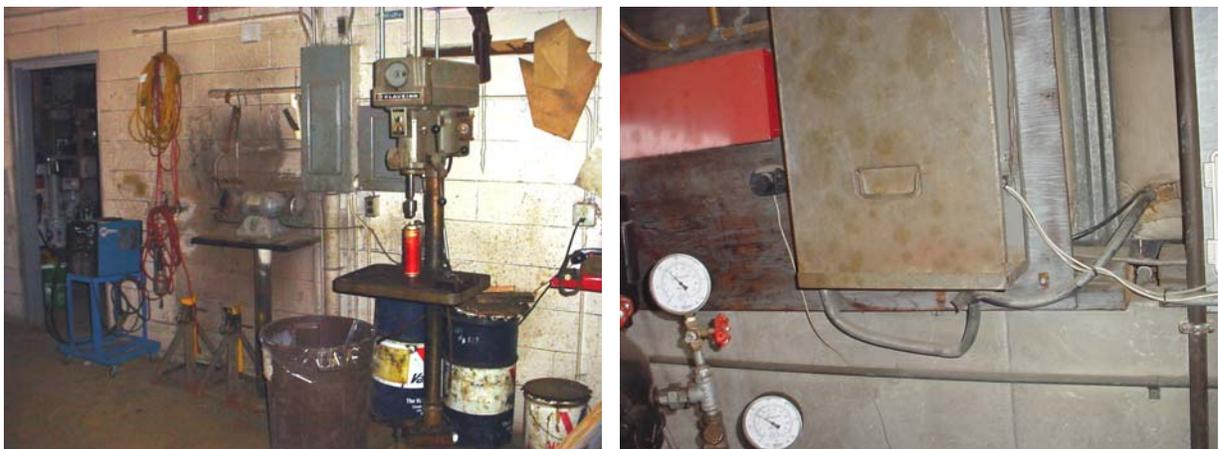
Figure 23 Existing Electrical Distribution Systems

Distribution panel boards located in the shop/repair area, which are wall mounted, presently have other equipment located in front of the panels, and therefore do not comply with current NEC code (Refer to Figure 23).

Ground fault circuit protection for receptacles located in the garage area need to be retrofitted or replaced with ground fault protection for personnel safety and NEC codes. Some conduit work needs to be reattached or re-supported in compliance with current NEC codes.

- Upgrade exterior lighting to provide coverage to support night time activities
- Ground fault circuit protection located in the Garage
- Replace existing plumbing fixtures
- Provide backflow prevention for existing sprinkler and domestic water service
- Install a janitor room with a dedicated mop sink

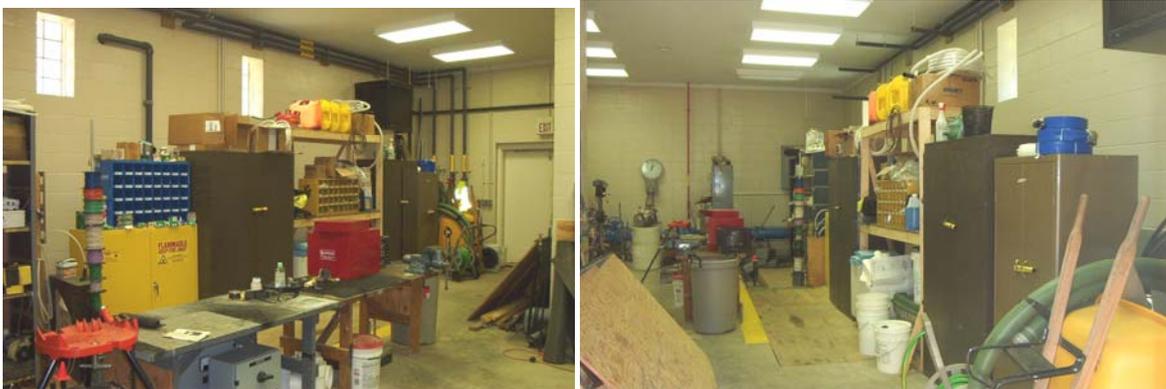
Figure 29 - Existing Storage Facilities

The current waste water facilities, including storage at the Hunt Road Building and garage space at the current police garage, contains approximately 2,855 net square feet. About 70% of the net floor space, or 2,800 square feet, is directly used for specific functions for pump and well equipment, electrical transformers, lab and lunch room, staff areas and storage (Refer to Figure 28 on the next page).

- Staff lockers and shower room (employee health)
- Adequate administrative work space and storage for current and future staff
- Covered garage storage for (6-8) vehicles (protection from the weather)
- Centralized storage of equipment and supplies (staff efficiency)
- Ability to expand facilities as future growth in town services occurs

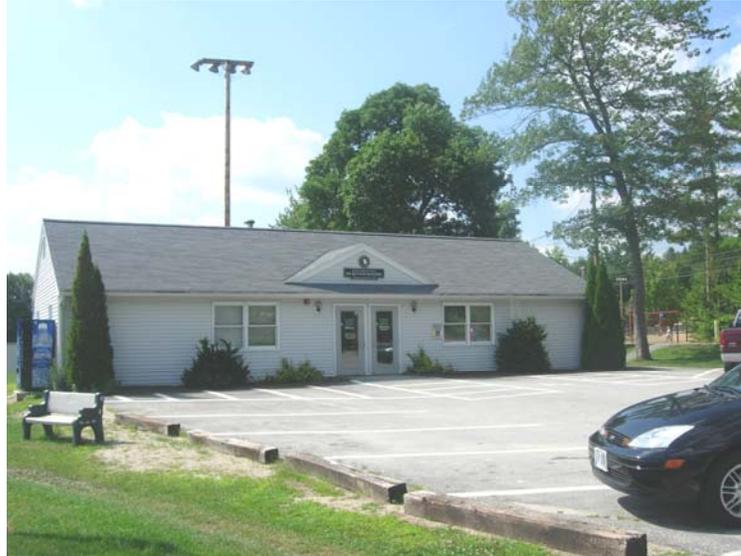
Figure 30 – Main Recreation Offices

The Main Recreation Building occupied by the Peterborough Recreation Department dates from 1995 and contains approximately 1,600 net square feet on one floor. About 91% of the net floor space, or 1,466 square feet, is directly used for specific functions for public use, administrative, conference room, public toilets and storage. The balance of the area is circulation space and mechanical rooms. Refer to Facility Needs Assessment by Department for a complete breakdown of space by specific function.
