### Department Description

### Characteristics of Existing Building

## Primary Building Systems

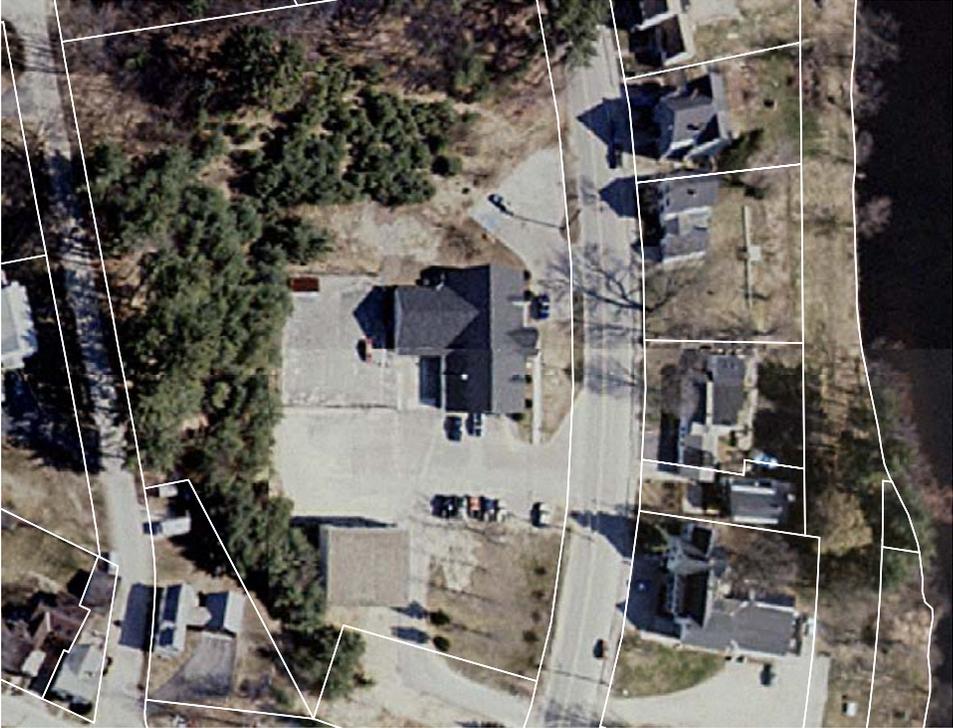
Figure 12 - Grove Street Police Station Site

The Police Department property is located in the General Residence District, at 73 Grove Street, just north of Route 101 (Refer to Figure 12 below)

The minimum lot size requirement for that District is 20,000 square feet for a one- or two-family residence. This parcel is approximately 3 acres. Approximately 8% of the lot is occupied by the structure, and 20% covered by impermeable materials.

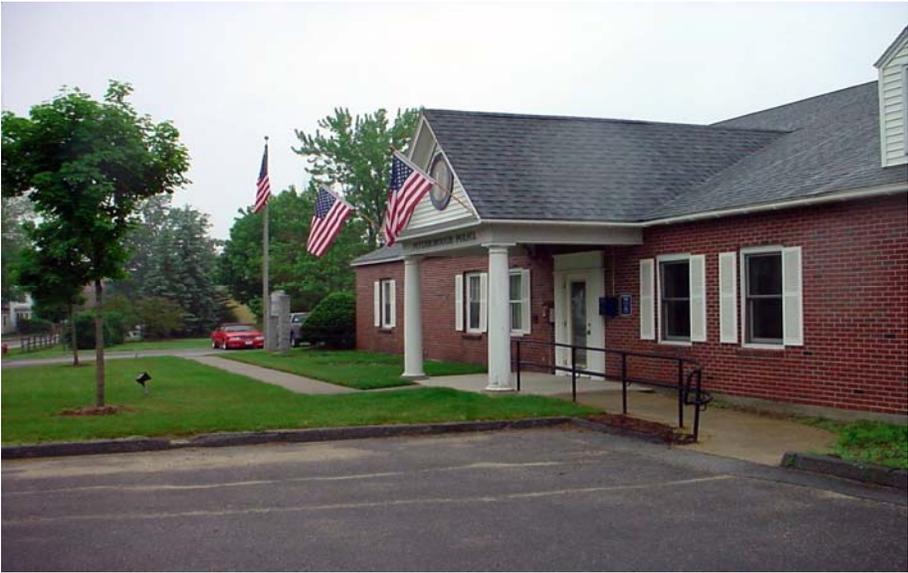
Figure 13 - Visitors' View of Existing Police Station

The current facility occupied by the Peterborough Police Department was formerly the PSNH office building, which was built in 1964. The Police Department moved in approximately 10 years ago (1995) following extensive renovations to convert the building for police use (Refer to Figure 13).

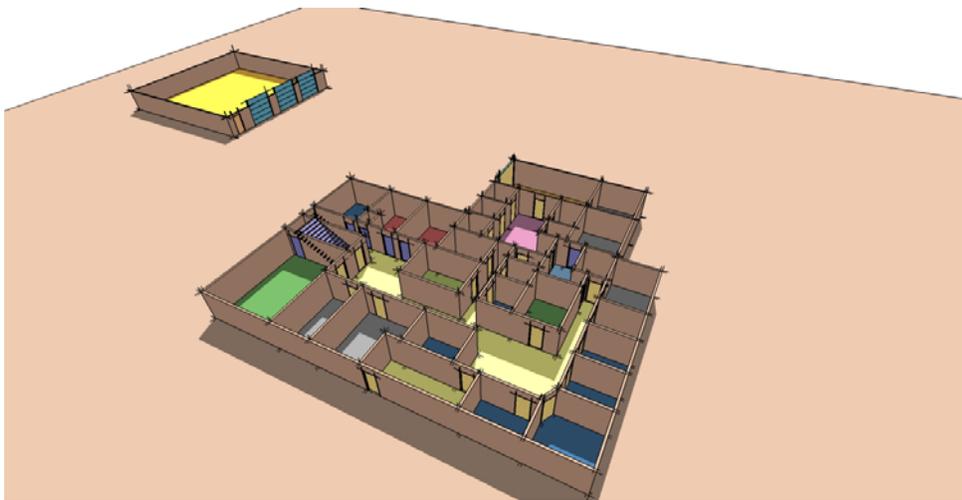
Figure 14 - Existing Police Department Layout

The current facility (Refer to Figure 14) occupied by the Peterborough Police Department contains approximately 6,850 net square feet on two floors. About 82% of the net floor space, or 5,614 square feet, is directly used for specific functions for public use, administrative and record keeping, police officers work areas, training, toilet rooms/showers, holding cells and archive storage.. The balance of the area is circulation space and mechanical rooms. Refer to Facility Needs Assessment by Department for a complete breakdown of space by specific function.

The current facility will need to address the following design issues in order to assure a modern police department:

- Security Issues of public areas from daily operations
- Formal interview room
- Evidence Room (security, and controlled environment)
- Additional archive record storage area

- Work space for future police officers
- Future space for 24 hour dispatch (police and fire)
- Separate holding and booking areas for Adults and Juveniles (isolated from sight and sound) per state law

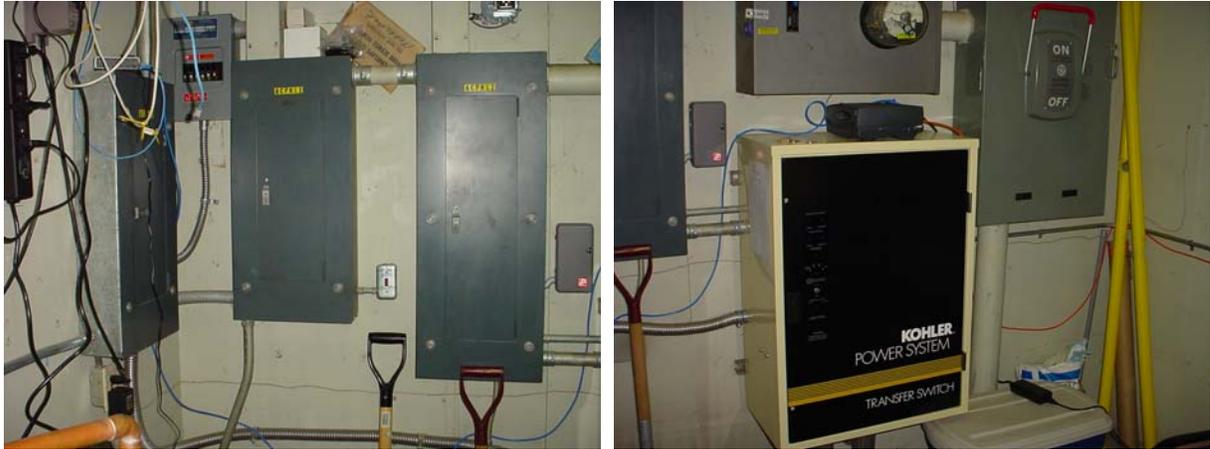
Figure 15 - Existing Electrical Panels and Emergency Power

Electrical service is a 400 amp, 3 phase with older equipment, which appears to be from the original construction when it was the PSNH office building.

Replacement of an older GE panel boards should be considered as part of any major renovation or expansion (Refer to Figure 15 on the next page).

Building is provided with a standby propane gas fired generator, Kohler 20 KW unit that appears to be approximately 10 years old. Equipment appears to be in good condition. However, the enclosure has been severely damaged by snow plowing operations and should be repaired as soon as possible.

- Additional space for 24 hour dispatch (police and fire) which will require new equipment and personnel
- Adequate separation of aggressive persons from the remainder of the prisoner population
- Separate area for juveniles from the adult population as required by state law
- Repair damage to standby generator enclosure
- Additional archive record storage area for 700 letter size files per year
- Security cameras

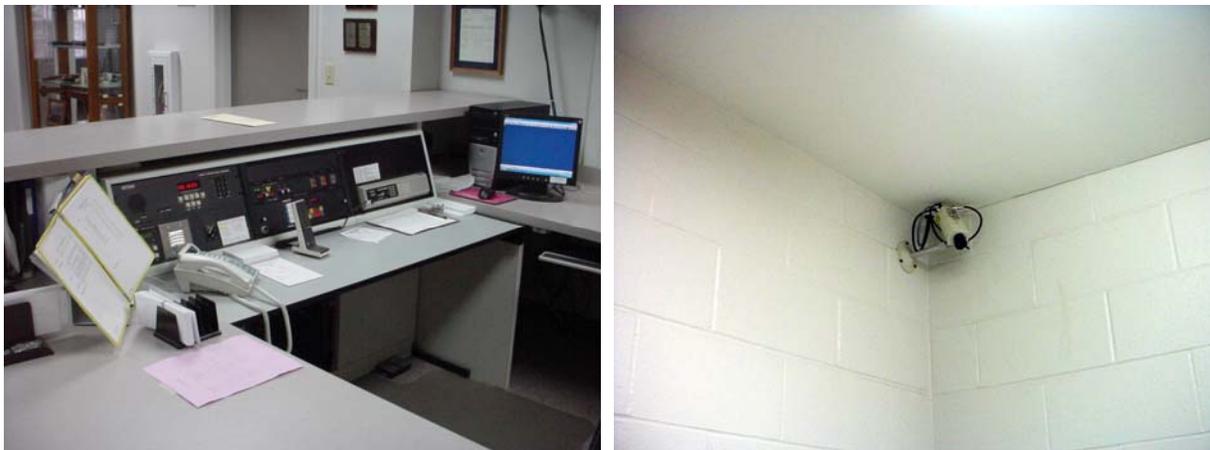
Figure 16 - Existing Communication System & Security at Sally-Port

The current dispatch and control center operates from 8 am to 12 pm and is not a 24 hour / 7 days per week 911 dispatch center (Refer to Figure 16).

The camera system in the Sally-Port and holding cell area is not operational and needs to be replaced.
